## **TAYNISH MILL**

AN ARCHAEOLOGICAL EXCAVATION

### **Data Structure Report**

May 2012

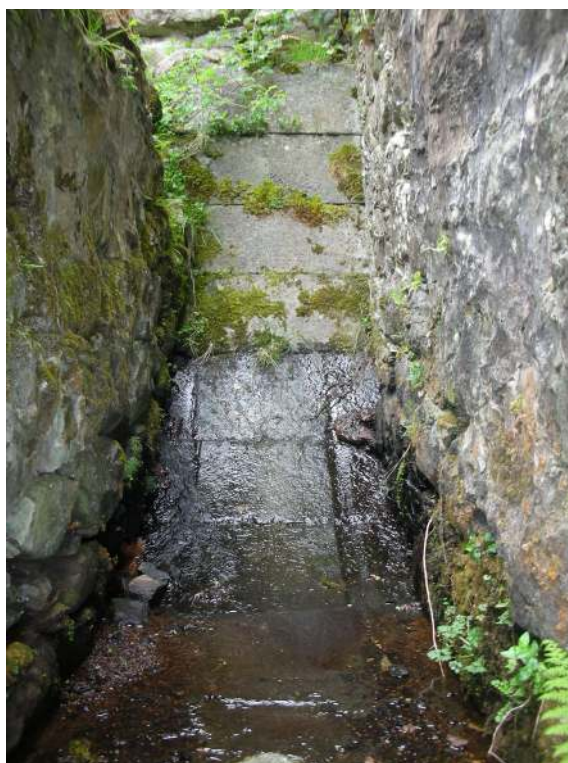
Wheel grooves worn in stone lined lade

The clearing out of the water lade has shown great results, There is now a very visible man made channel, with a substantial stone flooring to the channel, and some of the rocks have wear marks from the turning of the wheel. This being useful in determining the size and width of the wheel, From the evidence still available, there seems to be two distinct 'expert views' held about the type of wheel in operation here, being either pitchback, or high breast wheel. Both operating the wheel in an anti-clockwise fashion. It's my aim to return to the mill site with ladders and tape measure to further investigate the metal gearing still in situ, and hopefully get a accurate measurement of the wheel size

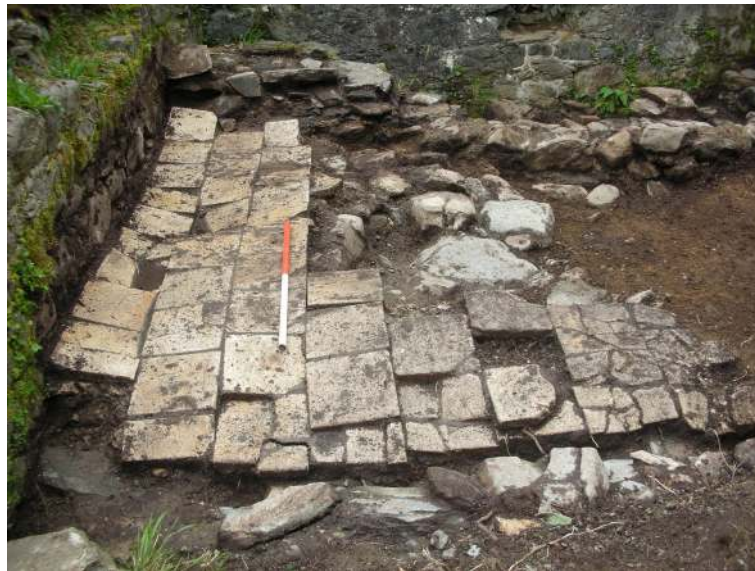
Floor [002]

[002] Floor. Consists of square light grey yellow ceramic tiles measuring 0.30m by 0.30m by 4cm

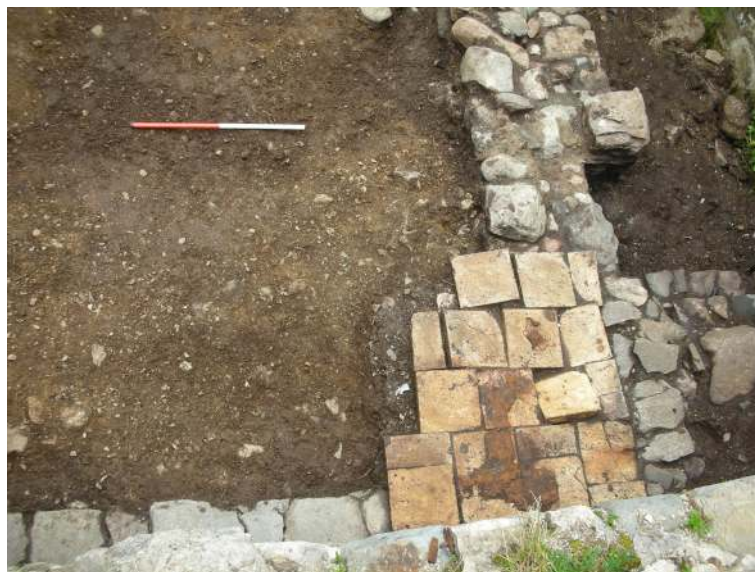
Floor [003]

[003] Floor. Consists of square light grey yellow ceramic tiles as described above, the floor also incorporates some bricks in the surface these measuring 0.24m x 0.11m x 60mm. The upper surface of the floor has a dark red brown ferrous rust stain suggesting a box or container sat here.

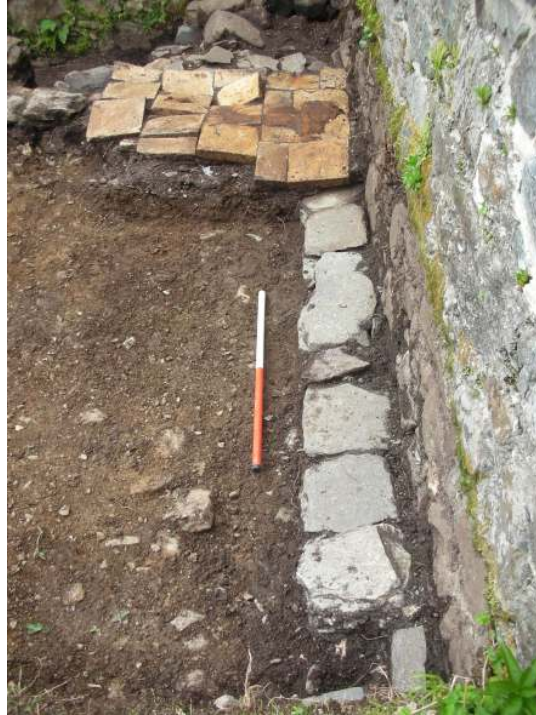
Sill [005]

[005] Ledge. Length of exposed sill or scarcement running along the NW wall. Consisted of a line of levelled stones measuring 0.30m wide.

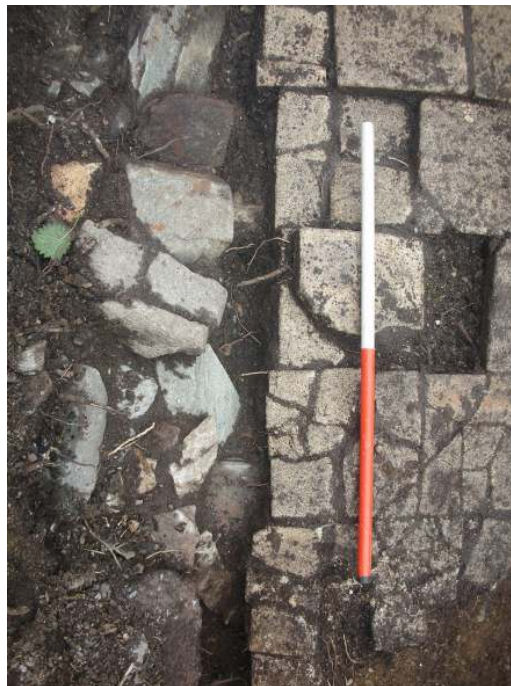
Beam-slot [006]

[006] Beam-slot. Linear void measuring 0.13m wide running across building, traceable at SE but less apparent at NW.

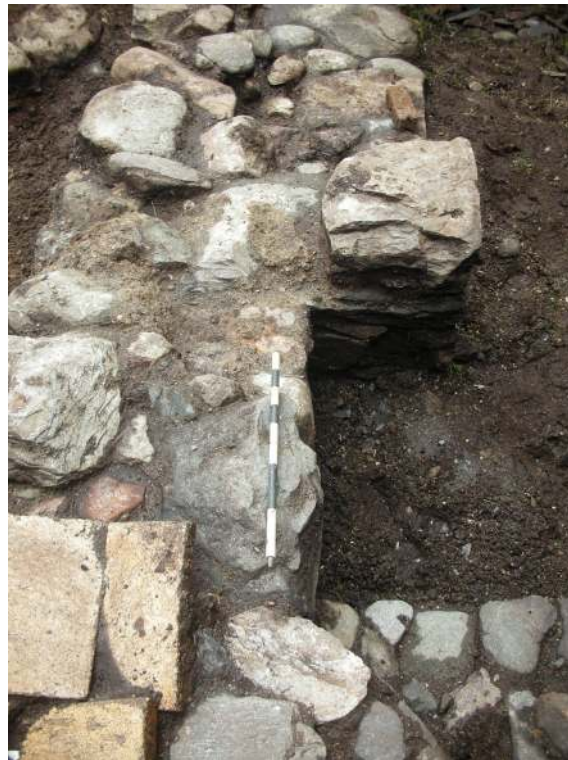
[014] Steps? The upper extent of a likely access step into the gear pit built of roughly coursed rubble blocks (maximum size 0.47m x 0.40m x 0.20m).

Step [014] in gear pit wall

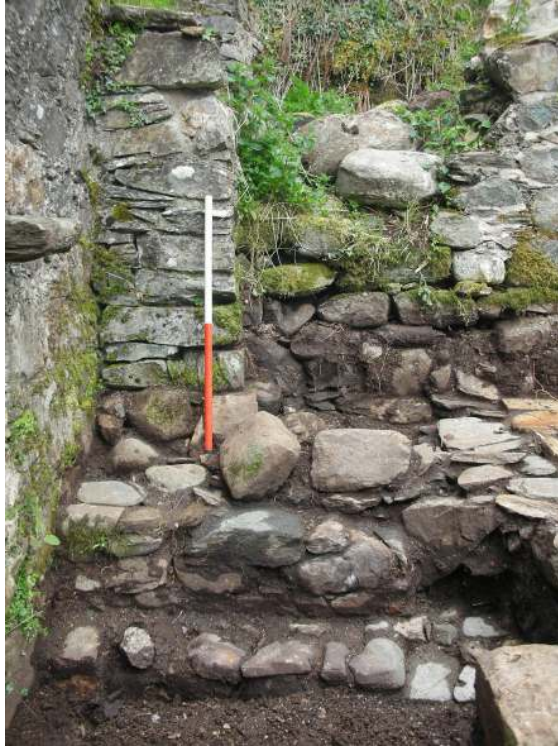
Pier/pillar base [015]

[015] Pier Base. Rubble built foundation of internal floor support. The main column measured 0.50m by 0.52m, stepping out at the base in successive steps by 0.5m, 0.55m and 0.3m over a height of 0.33m.

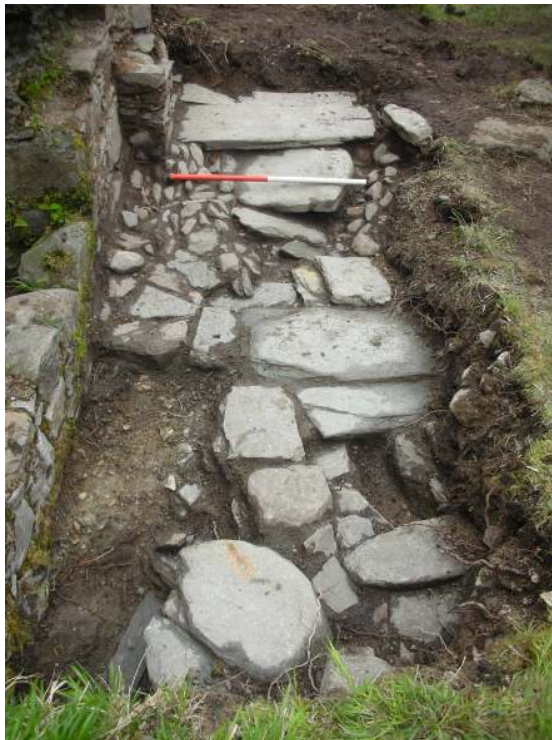
Surface [016] and Drain [017]

[016] Surface. Consisted of closely set water rolled cobbles and schist slabs running either side of drain [017].

[017] Drain. NW/SE aligned stone built drain. Comprised two rows of stones forming the sides of a channel 0.22m wide and 0.12m deep overlaid by a schist capping, forming the floor surface that corresponds to [016].

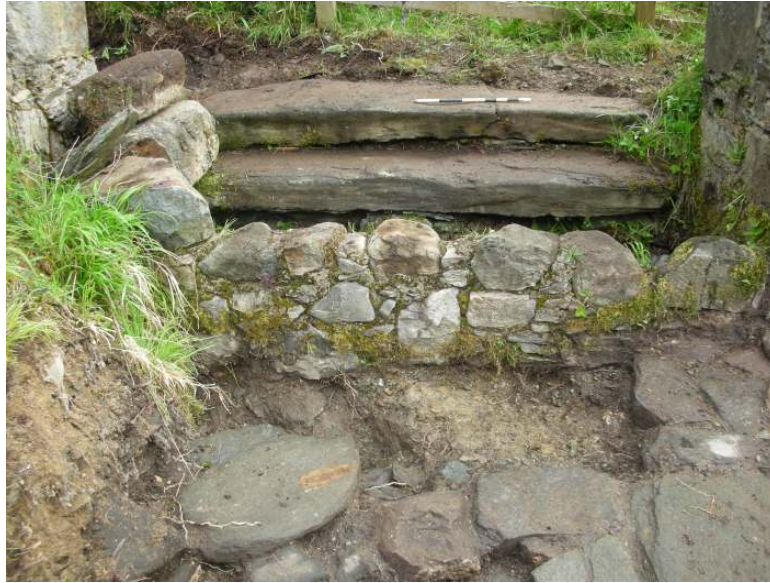
[019] Wall. Stone and mortar footings of former entrance blocking standing 0.56m high.

Blocking [019] with reused millstone within surface [016] in foreground

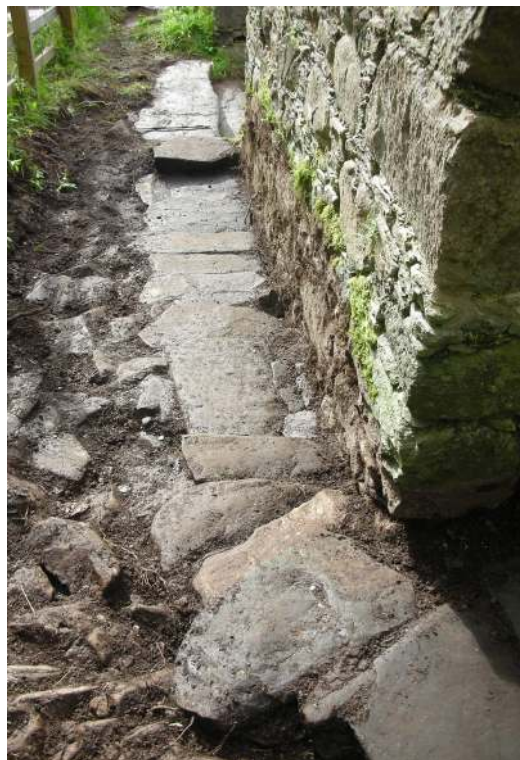
Drain [020]

[020] Drain. Line of capped drain running along the NW side of the building, consisting mainly of large to medium schist slabs.

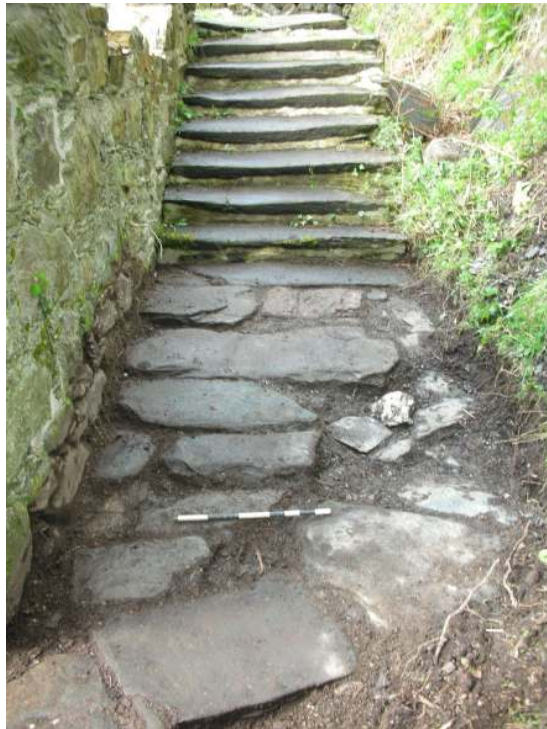
Surface [021]

[021] Surface. Stone slab surface running up to stairs along the NE side of the building.

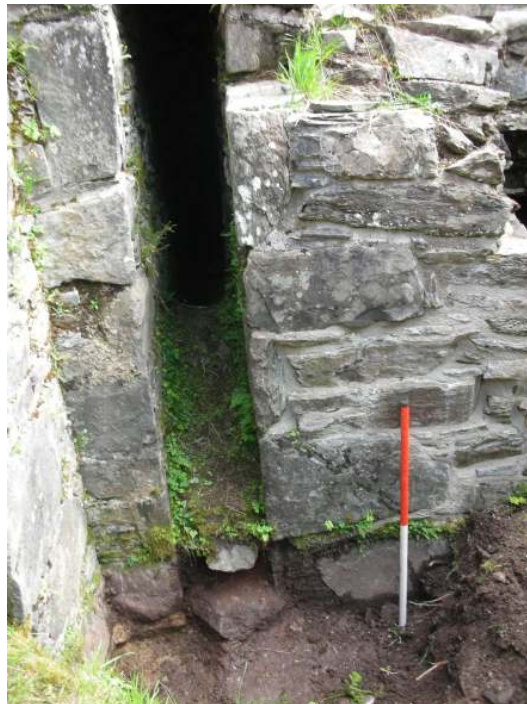
Clay floor [022] Trench 3

[022] Floor. Red brown silty clay.

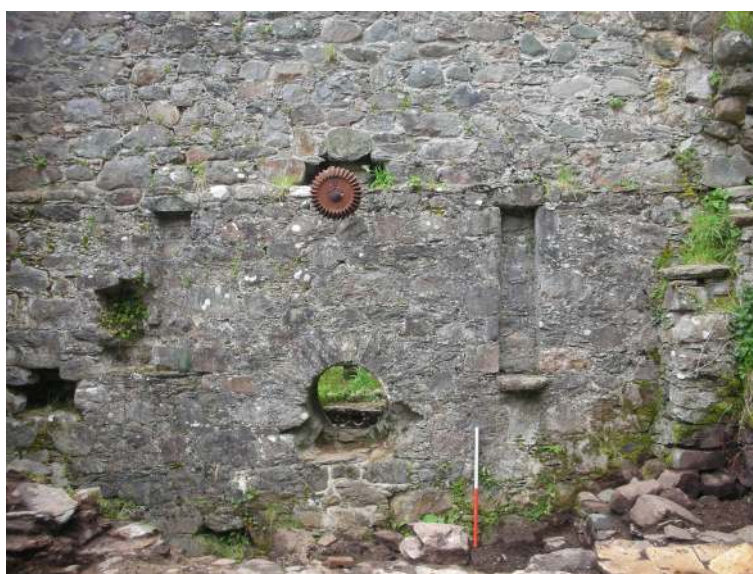
The axle passed through a 0.7m circular aperture in the end-wall, which retains some iron bolts for the axle-bearing, and on the SE perimeter of the wheel there is a recess for access to the rim, whose lintel is a truncated runner-stone with a four-winged rind (cf. No. 631. Latterly the wheel was evidently fitted with a rim-gear, driving a cast-iron spur-wheel connected by a shaft to a small bevel-gear inside the mill, both of which remain intact. The stones-floor was carried on a timber framework supported by vertical slots in the end-walls and sockets in the side-walk as at Aironn (No. 227), and additionally by an internal masonry pier in the NW angle.

Vertical timber slots, axle hole and upper gearing

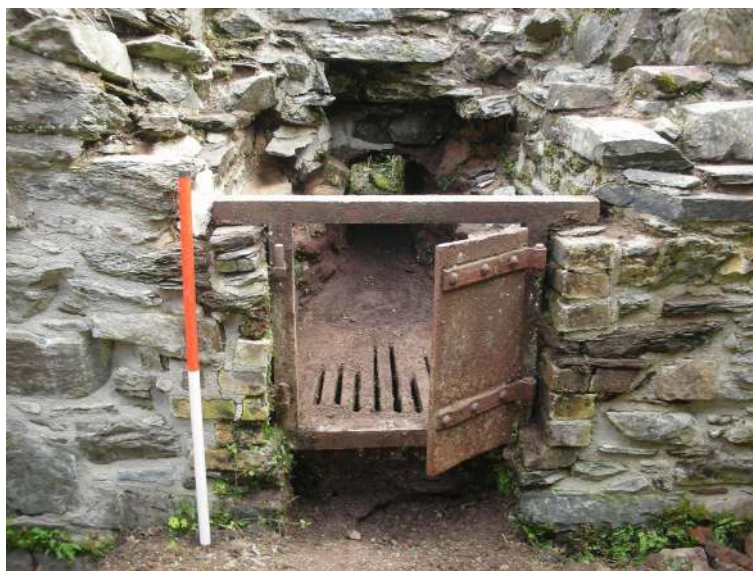
Fire box

1) Of major note within this rubble removal was the access gained to the firebox. Once access was made in here the ash pit area was totally cleared, showing the depth of grate, and as excavation continued the grate became visible - in one piece, and the second door to the firebox was excavated from within the firebox itself. The doors to the firebox are cast and of heavy form, both have corrosion, but this could be removed/reduced through restorative techniques.

The RH door is seized in place, and it may be of some concern that someone will come along and try and force this to move; possibly resulting in breakage at the hinge. The LH door has one hinge bracket missing, a new one could be fashioned by a blacksmith for replacing in its original position. The infill into the firebox was removed and cleared overhead, this has exposed a very good example of a brick lined firebox, leading away into a tapered flue within the kiln, This merits further examination, possibly from above, Exploratory trenches were also dug in other areas of the site, largely for future recommendation; (numbers are taken from 'excavation sites' map-marked in red).
