**CARNASSARIE CASTLE,
ARGYLL**
Beyond the Bishop, a Community Excavation

Data Structure Report

July 2017

Carnassarie Castle; Beyond the Bishop, an Archaeological Story

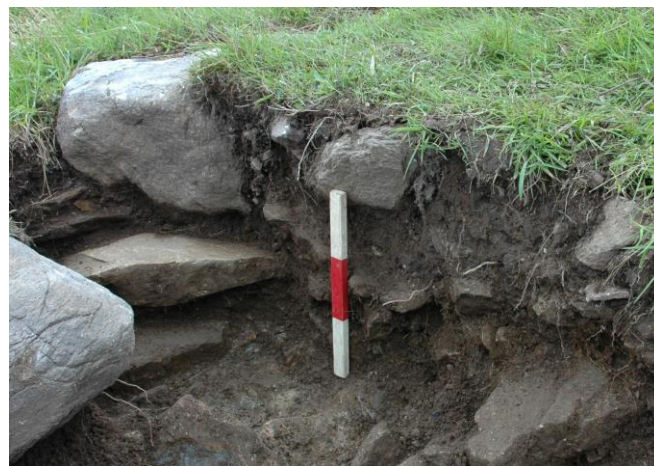
The trench extension, as hoped, revealed the surviving internal face of the dun wall [050]. The wall appeared to have been constructed within a cut [049] excavated through/into the natural sub soil/bedrock. The natural consisted of ridges of epidiorite schist and quartzite in between which laid more clayey sands and gravels, likely the remnants of glacial till.

Inner face of dun wall [050]

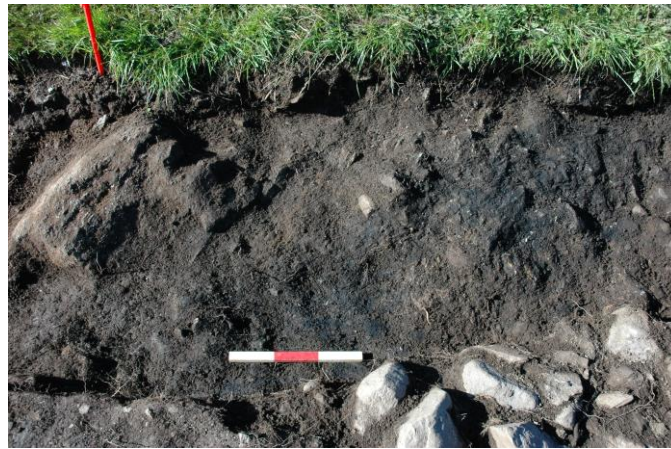
Deposit [033] lay mainly over natural bedrock but continued north beyond the edge of excavation where it looked like it was becoming thicker. To the west of the natural ridge and also overlain by [033] was what appears to be trampled surface of pebbles and small

Ash Deposit [033]

[033] Layer. Deposit of trampled? fractured/broken stone (some burnt) within a mixture of red/brown and dark grey soil, including ash and charcoal.

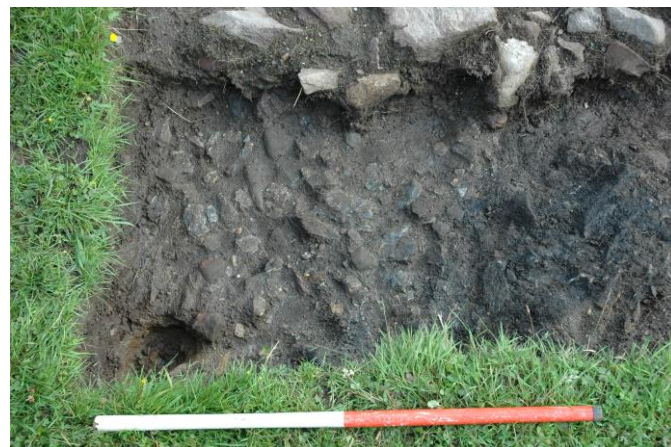
fragments of rock [035] this surrounding what may have been a post setting [032] (fill [031]), although given the later disturbance in this immediate area (see below) this interpretation has to be treated with caution.

Surface [035] and possible post hole [032]

[035] Layer. Deposit of trampled fractured/broken stone (some burnt) within a mixture of red/brown and dark grey soil, including ash and charcoal.

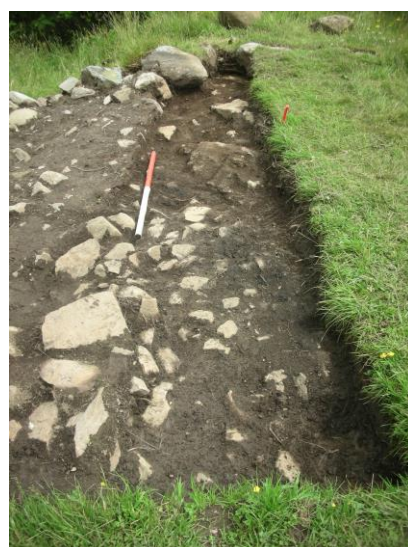
The trampled surface [034] and burnt deposit [033] were both sealed by a mixed deposit burnt of fire reddened and fire cracked stones [017] which also contained charcoal.

Occupation deposit [017]

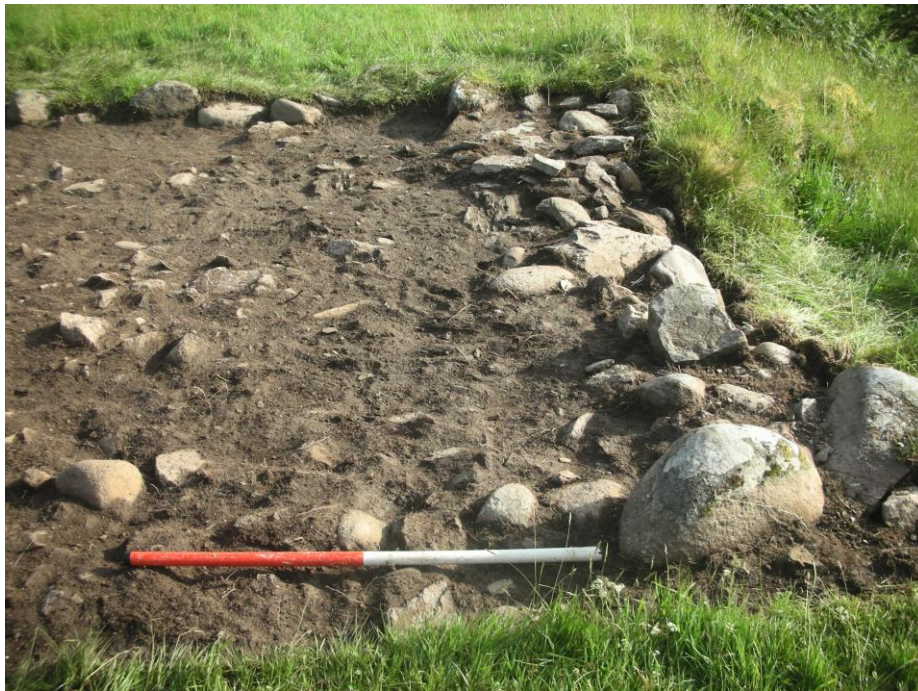
Sealing this occupation derived material was a layer of red brown sandy silt [016], which particularly at the east, contained rubble presumably derived from the disturbed dun wall.

Dun wall rubble in [016]

[016] Layer. Red brown clayey silt with occasional limestone or cobble fragments, with rare charcoal and burnt bone.

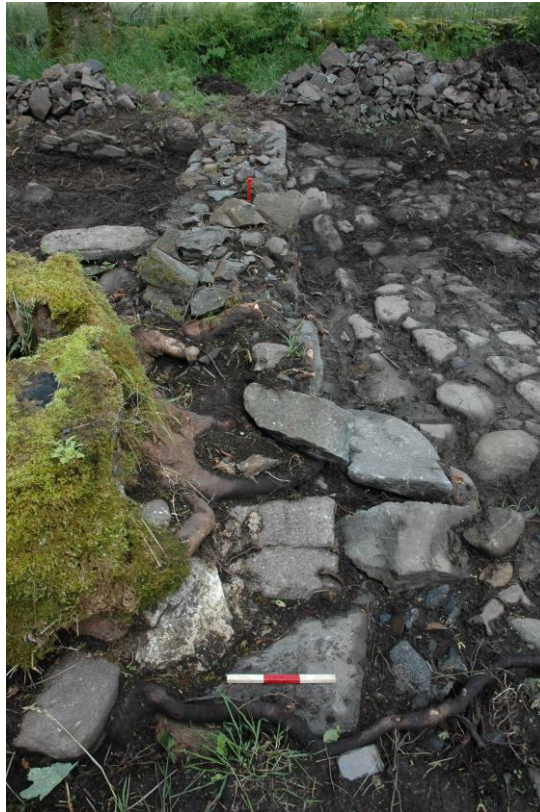
Only a small portion of Building 5 was uncovered, due to the presence of extensive tree root systems making excavation particularly difficult. This building measured approximately 4.2m in length and 3.80m wide internally. The walls of this structure [042] were bonded in part with a hard light brown lime mortar containing what appear to be small fragments of broken ceramic tile. The walls of the structure had been heavily robbed particularly those on the

eastern and western sides the best surviving wall being that at the north, this standing up to 0.60m high and 0.84wide.

North wall of Building 5 with mortar bonding left of scale

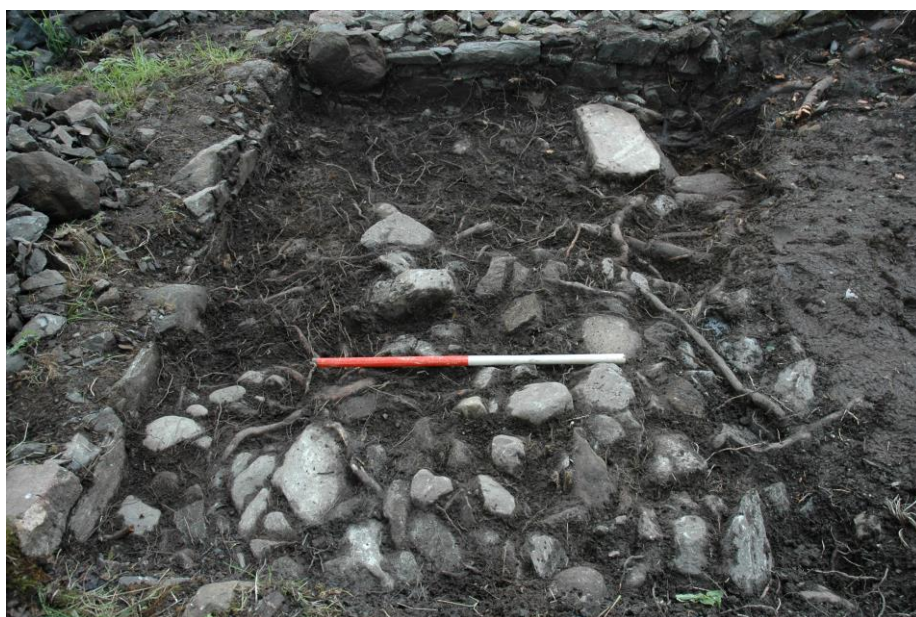
Within the walls were the remnants of a cobbled floor [043] and some patches of clay floor (with some indications of burning) although the later had been badly disturbed by roots. Towards the centre of the floors was a drainage channel [053] leading to an outlet against the north wall. Some pottery was recovered from the drain fill suggesting a mid 19th century use.

Cobbled surface [043] in Building 5 with drain outlet at upper right

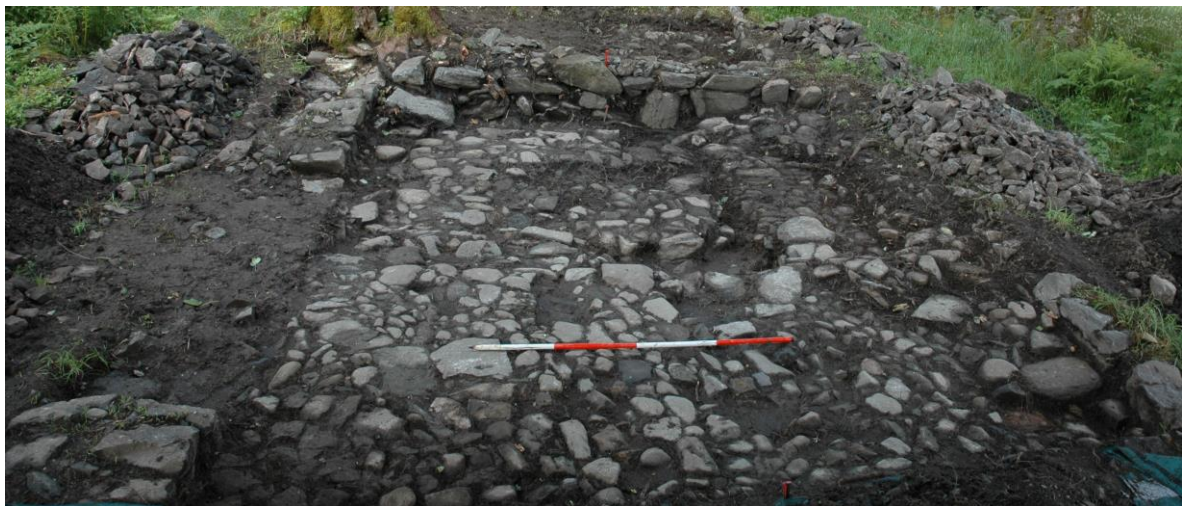
As with Building 5 the walls of the Building 4 had been heavily robbed on the east and west sides although the surviving walls indicated this was a large structure measuring c 9.30m long and 5.10m wide internally. The south eastern wall of this structure had been constructed against the walls of Building 5 indicating that Building 4 was a later addition. The walls contained an extensive cobbled floor with a series of channels for internal drainage suggesting this functioned as a byre building.

Cobbled surface [031]

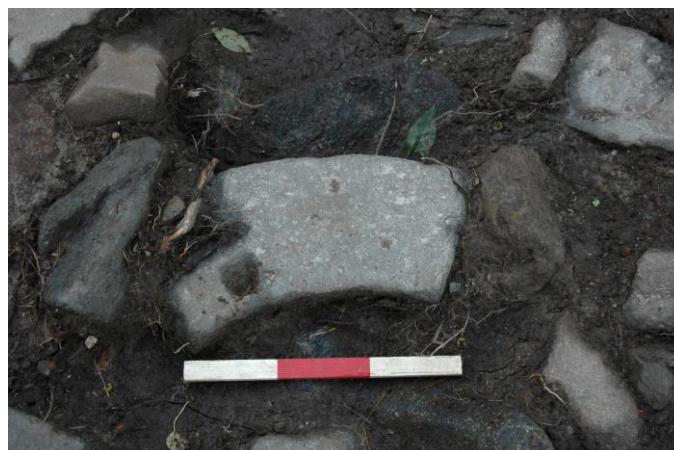
Several fragments of green schist had been utilised in the cobbled surface, these, especially one carved example, no doubt came from the castle and suggest the floor was constructed after the late 17th century when the castle became disused.

Part of arch used in cobbled floor of Building 4

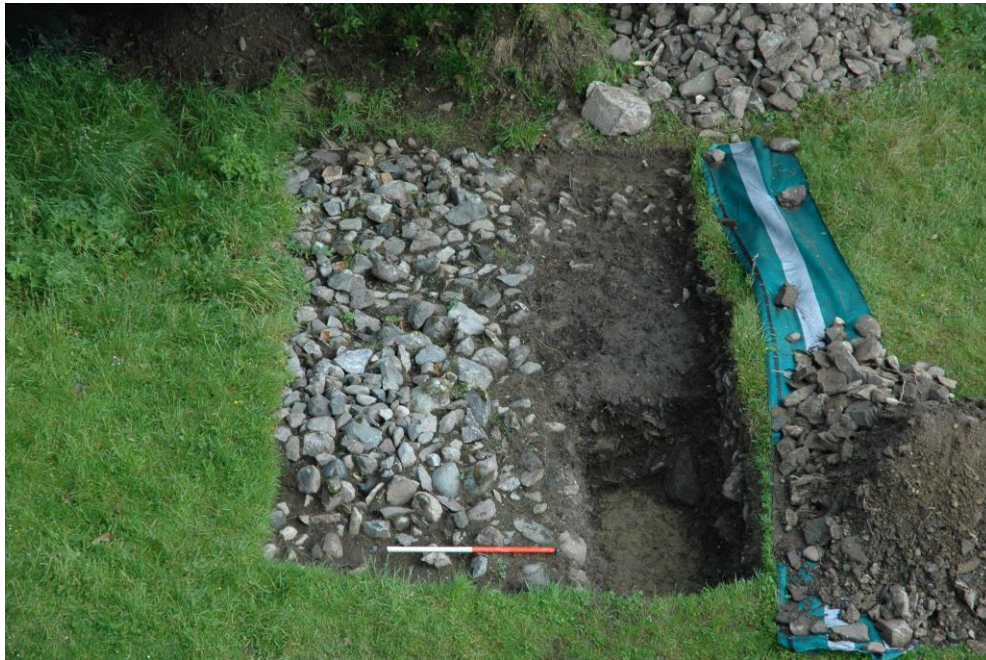
Trench 4 from above

Over this dumped deposit, was a loose deposit of mainly water rounded cobbles (some quite small) with a few fragments of more angular epidiorite/limestone [005]. This deposit forms the heaped arc that extended beyond the trench to the east and westwards towards the garden gate. The rubble also contained fragments of moulded stone (castle derived) and small broken pieces of drainage tile. Also recovered from just below this deposit were fragments of a plastic wrapper and some silver paper, possibly the remnants of cigarette packet. While these may be intrusive, i.e. introduced by a rodent, they and the very loose nature of much of this deposit suggests a relatively recent date. What this deposit represents is difficult to discern but may be the remnants of material intended to be used as an external surface or track around the castle but never used.

[005] Layer. Cobble and stone dump. Mounded arc of rubble consisting of loose small to medium water rounded cobbles with occasional limestone and epidiorite schist fragments in a mid brown sandy silt. Includes broken drainage tile fragments and glass.

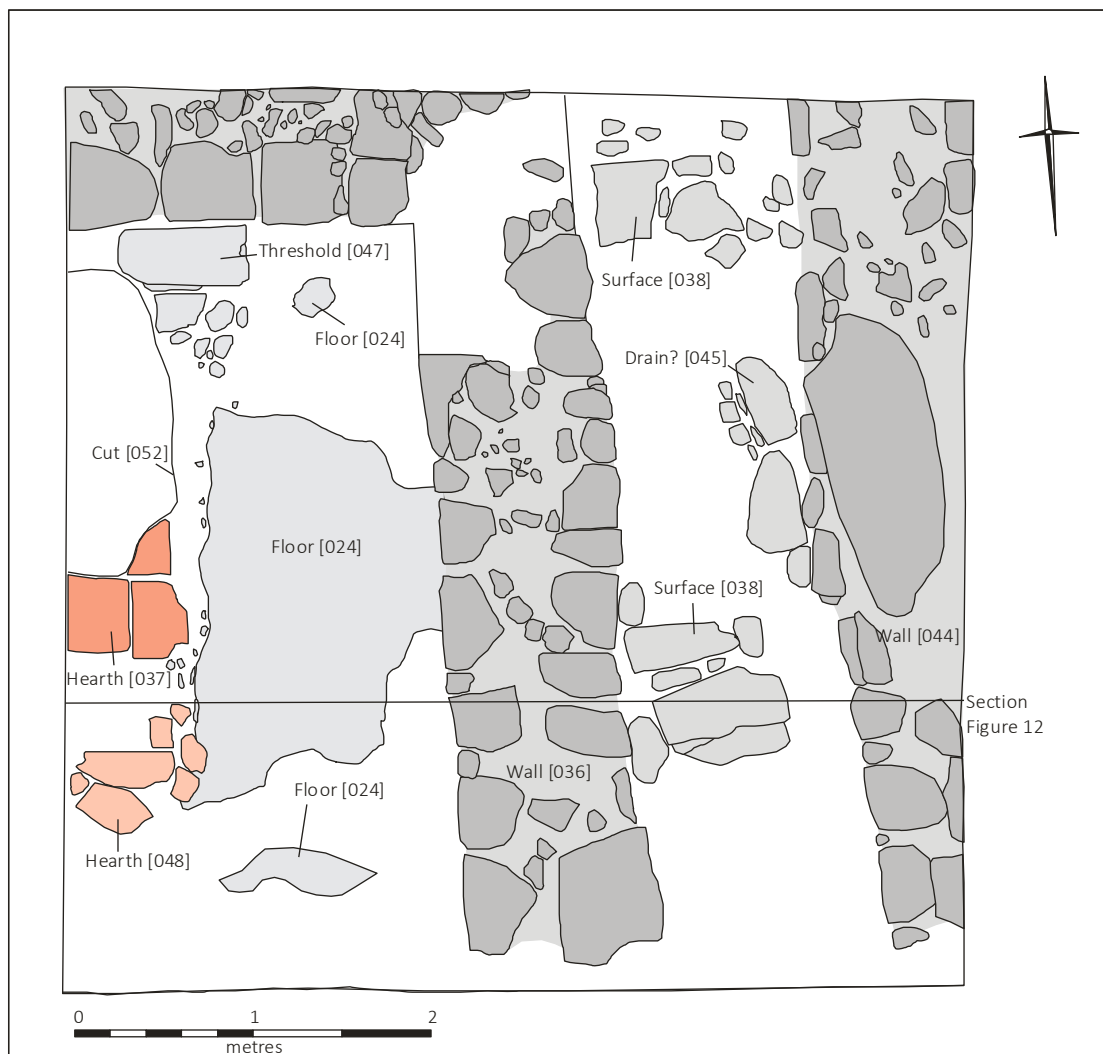
Figure 10: Trench 5

Trench 5 (5m x 5m) was placed either side of a north south oriented rise that what was presumed to be a wall. The presence of a wall [036] was quickly established and this effectively divided the trench into eastern and western parts each with their own archaeological sequence.

Wall [036] was the eastern wall to a structure (Building 3) measuring c11m long by c6m wide externally. The inner face of the northern wall was also revealed in the trench, although the NE corner had been robbed. The later robbing allowed the observation that the walls had been constructed directly over natural sub soil consisting of a yellow brown sandy silt and gravel. Internally the building had been provided with a series of clay floors [024]

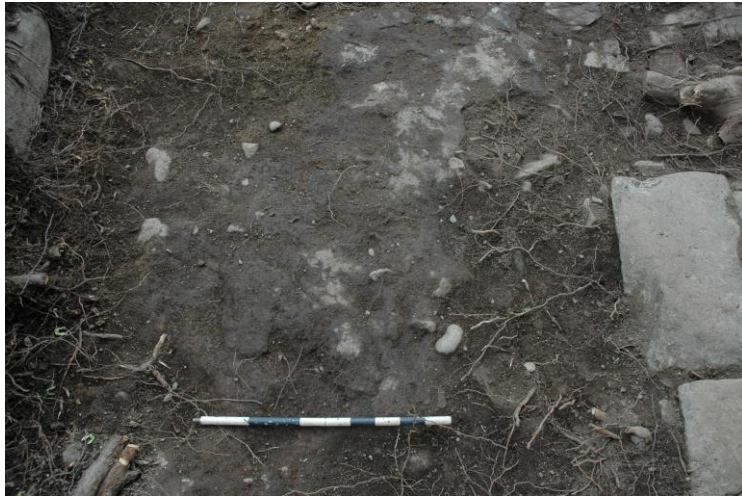
Clay floor/s [024]

[024] Layer. Floor consisting of tamped clay and coarse gravel, some of this stained with ash.

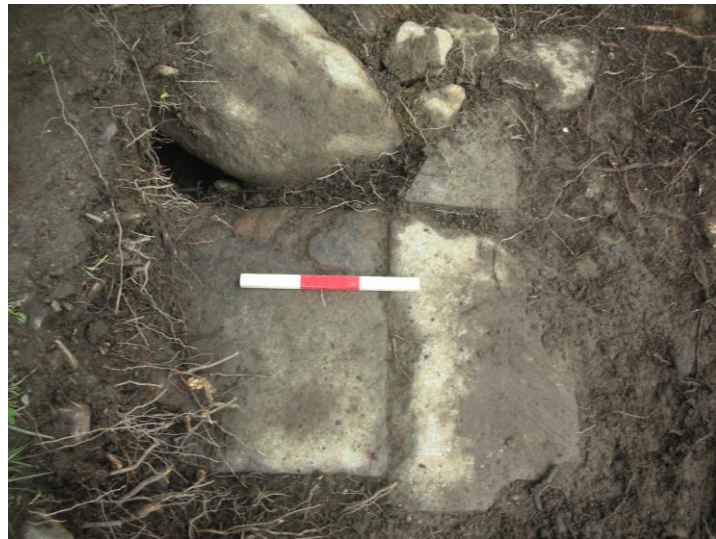
surrounding two stone hearth settings [037] and [048]. The sequence of floors *vis a vis* the hearth settings unfortunately could not be established due to extensive root disturbance through these relatively 'soft' floor deposits. Only the better preservation of hearth setting [037] suggested that this might be later, but no stratigraphic relationship was established. There was also some evidence that the upper floors had been repaired particularly around the hearths while the rough cobbling around the threshold stone [047] at the north side the room also suggest these are later additions/adaption's to the original build.

Hearth [037]

[037] Hearth. Hearth constructed from three horizontal slabs of epidiorite schist, which show some signs of burning/scorching. Measures overall 0.78m by 0.70m.

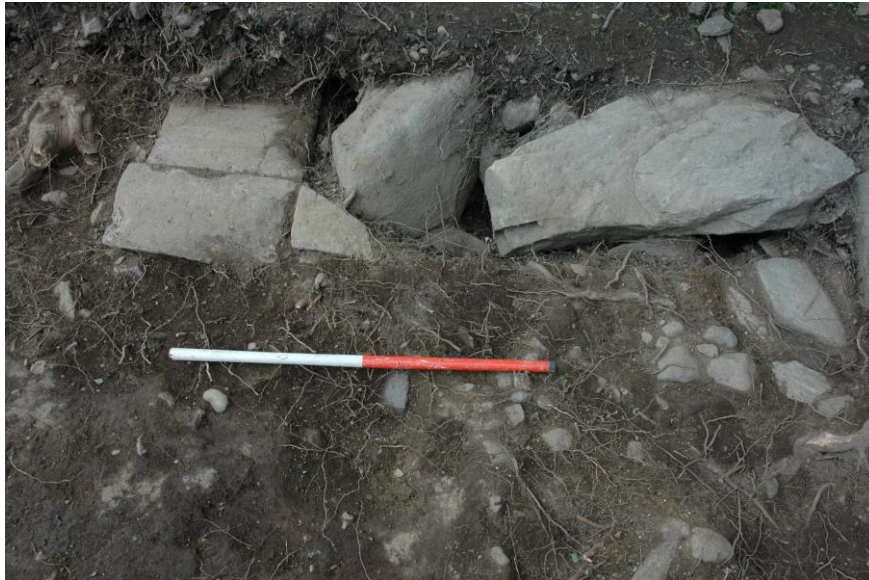
The building appears to have gone out of use and subsequently levelled by a deposit of mixture of rubble in mid brown loam [012]. Cutting through all of these was a large cut, filled with very large blocks of limestone [051]/[052]. This feature currently eludes explanation although the cut was very rectilinear and suggestive of a machine excavation, is it possible that the 'landscaping' of the area around the castle led to the burial of inconvenient stones?

Cut [052] filled with large boulders

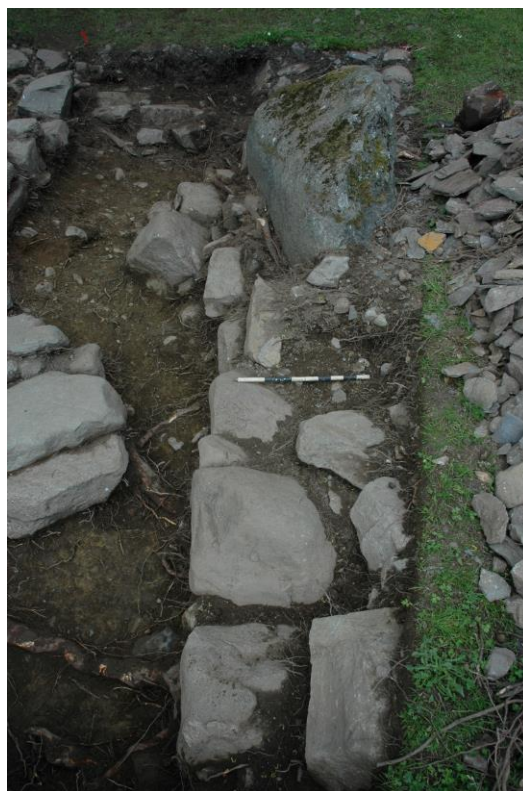
To the east of wall [005] and bounding the edge of the excavated area were the robbed remains of north south aligned wall [044], which was the south western end of a building or range aligned north/south, Structure 2. The wall was constructed from large blocks of limestone and quartzite with smaller stones used in packing.

Wall [044] from south

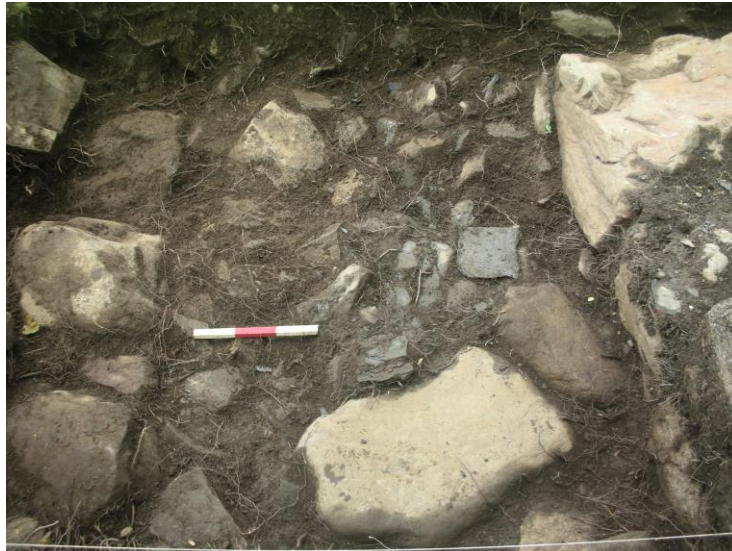
Lying between walls [044] and [036] were the remains of a cobbled surface [038] and possibly a drain [045] running along the eastern side of the corridor surface although both had been extensively disturbed/robbed. This presumed robbing allowed the observation that the remnant cobbled surface (and drain) along with the walls of both structures had been constructed directly onto natural subsoil. The surviving cobbles/surface at the N of the trench were sealed by a deposit of dark silty clay [030] (possibly representing late use). To the south of this and lying over the remnants of the surface and against both walls was a deposit of roofing slate [018], suggesting stone robbing of the surface had occurred just prior to a slate roof being removed from one of the structures. No such deposit was encountered within Building 3 perhaps indicating the slate deposit was derived from Building 2, this being demolished and robbed while Building 3 was still being used. The deposit of slate was sealed by a mixed deposit of rubble, schist and sandy silt [013] which also had some evidence of some midden material being mixed within the rubble/demolition material accumulating in the space formerly occupied by the corridor, possibly after both buildings had gone out of use. The southern extent of the trench was occupied by the 'formal garden wall' which here appears to be a much later addition completely truncating what would have been the southern walls of Buildings 3 and 4 and their associated deposits on this side of the trench.

Slate dump [018] over cobbled surface and between walls in corridor

[038] Cobble/slab surface. The remnants of a stone surface running between buildings 3 and 4. The largest surviving section measures 0.80m by 0.80m and constructed from limestone blocks smoothed by wear.

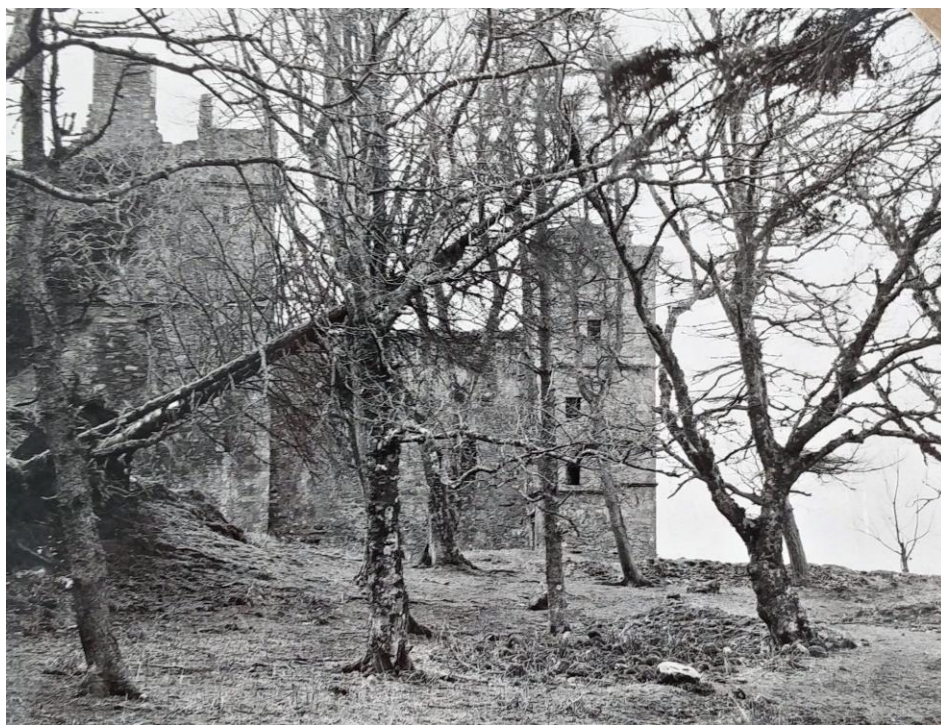
Photo c.1936 provided by HES showing area the castle from the north

A scan of a photograph, shown above, from an album of the Scottish Record Office, dated c.1936 and provided by HES shows the area to the north of the castle with what appear to be rubble dumps in this area (catalogue no. 551 359/541/1). Why the rubble was dumped here is still unclear but it is possible it was brought onto the site for some landscaping or planned hard standing that was never completed. Beneath this arc of rubble was a thick deposit containing demolition or collapsed material that appears to be castle derived and is likely the result of the clearance of rubble and collapse from its interior. Again when this happened is hard to gauge, but the clearance of the castle may have occurred sometime after the purchase of the castle by the Malcolm's of Poltalloch in 1829. By the mid 1850's the Malcolm's were creating an extensive designed and improved landscape centred on the newly built mansion of Calton Mor. This designed landscape incorporated many of the ancient and historical monuments around Kilmartin Glen and undoubtedly included Carnassarie castle which, as a 'romantic' ruin, would have been visited by guests of the estate. The relationship between the monuments in the area, including the castle and the Malcolm's designed landscape warrants further study as it has implications for its preservation and past presentation of the castle, but this is perhaps beyond the scope of this report. There is also evidence from Trench 6 that a structure has been removed from this part of the site, although again when this happened was not clear from the excavation results. Later landscaping possibly by the Ministry of Works in the 1930's may also have important implications for what we see today around the castle. The large rectilinear cut within Building 3, filled with large stones can perhaps be explained by attempts to 'tidy up' the site. Similarly, there appears to be a whole band of large stones lying between the castle and Carnassarie Beg, some with evidence of drilled bore or blast holes their presence as yet unexplained. What is clear is that a better understanding of this landscaping chronology would lead to a better understanding and interpretation of the castle grounds.

The excavation also revealed the fairly extensive damage to the site from surrounding trees, particularly to walls and any 'softer' floor deposits. The photograph shown below also shows the extent of tree cover at that time which is clearly much more extensive than at present, particularly on the dun knoll.
