# **CRAIGGLASS**COMMUNITY EXCAVATION

Project Report November 2005

## Roderick Regan, Sharon Webb & Heather James

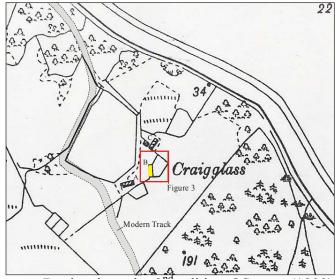
Figure 2: Craigglass as Depicted on the 2<sup>nd</sup> edition OS map (1900). (The excavation centred on Structure B shaded yellow)

Structure B was chosen for excavation as it appeared to have been abandoned earlier than the other structures of the settlement as suggested by its unroofed condition in 1900, with Structures A and C shown as still roofed at this time.

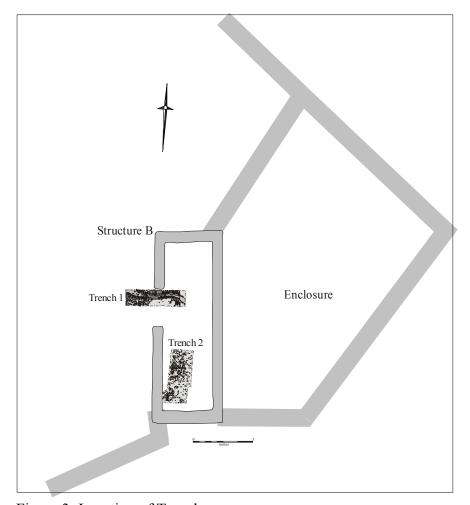
In the 2004 an area through the presumed doorway of the structure was excavated, Trench 1, which measured 5m by 1.30m, when fully excavated (Figure 3).

Figure 3: Location of Trenches

The 2005 excavation concentrated on the southern end of the building, in order to establish whether the building had been formerly divided into byre/living areas. The presence on established hawthorn and large collapsed boulders meant a rather irregular shaped trench was established, Trench 2 (Figure 3). Trench 2 measured 4.50m by 2m, with the south western side of the trench abutting the western wall of the structure.

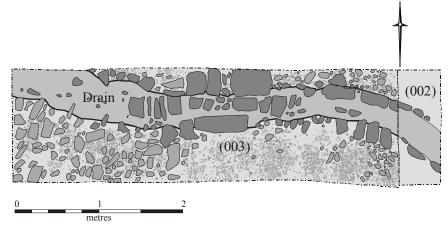
Figure 4: Trench 1

The topsoil, deposit (001) consisted of grassy turf and some dark brown humic loam interlaced with numerous roots. (001) varied in depth between 0.10m and 0.26m. Immediately under the topsoil was deposit (002), a dark brown silty loam (peaty).

This deposit was slightly darker grey within the drain (003), although no real difference within the overall deposit was noted. Deposit (002) was deepest where it lay within the drain, being up to 0.25m deep. This deposit contained numerous pottery fragments with less prolific glass, tobacco pipe fragments and iron objects. Cobbled surface and associated drain (003) was sealed by deposit (002). The surface in the main consisted of roughly lain fragments of limestone/schist set in a red brown matrix of burnt clinker or schist. The maximum size of stone used was 0.80m x 0.26m x 0.15m, the larger stones being utilised within the sides of the drain along the threshold/doorway line. The drain formed an elongated 'S' shape from east to west, curving south within the internal space of the building (Figure 4). Some basal stones remained 'in situ' lying flat along the base of the drain, the drain measuring up to 0.60m wide and 0.25m deep. Structure B (004), is partially described above, externally the building measured 16.50m long and 6.20m wide, with the walls up to 0.95m thick, with faced stone used in the surviving corners.
