DUN MHUIRICH, NORTH KNAPDALE

CONNECTED COMMUNITIES PROJECT

EXCAVATION DATA STRUCTURE REPORT

July 2012
Roderick Regan

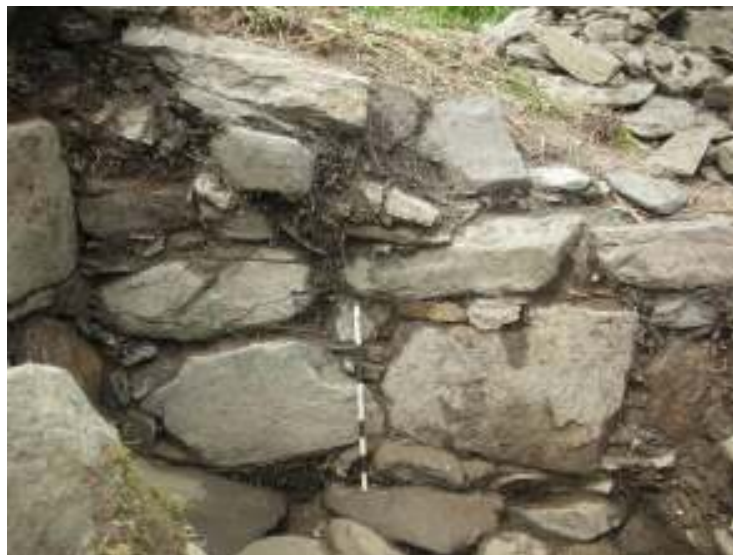
Structure 1 E facing wall

The lowest deposit reached was what would appear to be a partially cobbled floor set in grey clay [050]. Contemporary with this floor would appear to be a post [036] in the corner of the building, this at the W side of a projecting ledge or scarcement [049] running along the foot of the inner face of the SE wall. It is possible this ledge was constructed to support a suspended wooden floor, although little trace of any such floor has survived. A layer of trample [040], had formed over surface [050] and this was sealed by a layer of uneven rubble [035] overlain by a loose but generally even deposit of clay and schist fragments [034], these interpreted respectively as a make up and surface deposit. Thereafter this surface is sealed by a series of collapsed wall material and possibly the remnants of later robbing recorded as deposits [024], [016] and [011]. The only finds associated with the building was shell, and this was recovered from the collapse/rubble deposits.

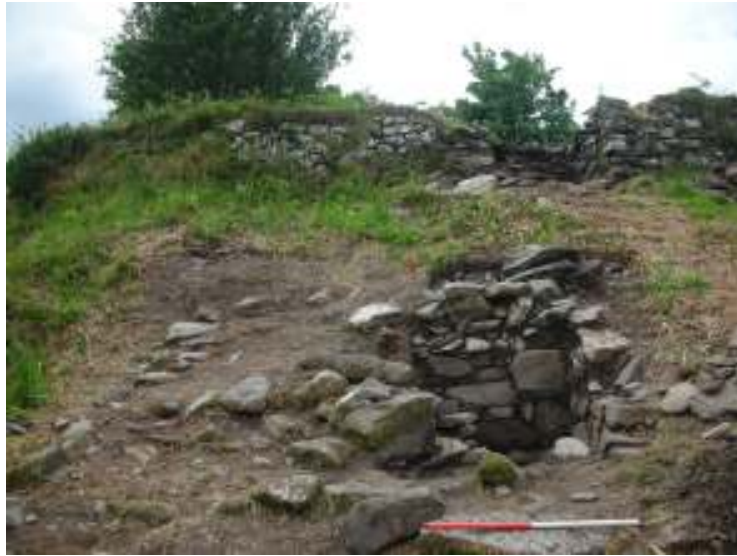
Position of Trench 1 below enclosure wall

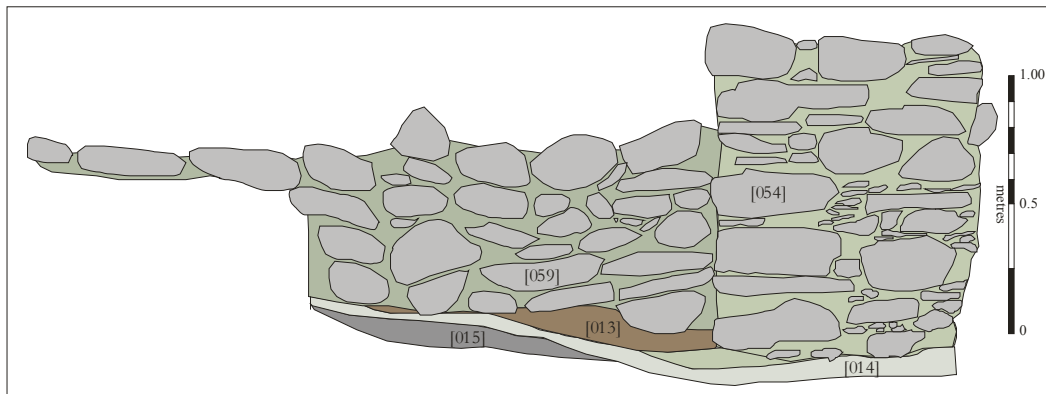
Figure 10: Trench 3 E facing section

This suggested that the construction of the stone pier may also have involved the partial rebuilding of the enclosure wall as further suggested by the fact that the stone work of the pier ties into the inner face of the enclosure wall. This construction phase was sealed by layer [013] which may represent an occupation deposit or surface as it contained animal bone along with several iron objects including a knife. A coin dating to the reign of Charles I was also recovered from this deposit. This was a two penny piece or 'Turner' which was the only Scottish coin minted during the civil war and dates between 1642-50. Above this was constructed wall [059] which effectively divided the internal area of the N side of the lower enclosure E and W of the entranceway. After this the wall [059] and pier [054] begin to degrade leading to an accumulation of collapsed stone [004] along their E sides. Mixed amongst the lower collapse was what appeared to be occupation or midden material, with bone, shell and several metal artefacts recovered from amongst the collapsed stones, including a knife and sickle blade.

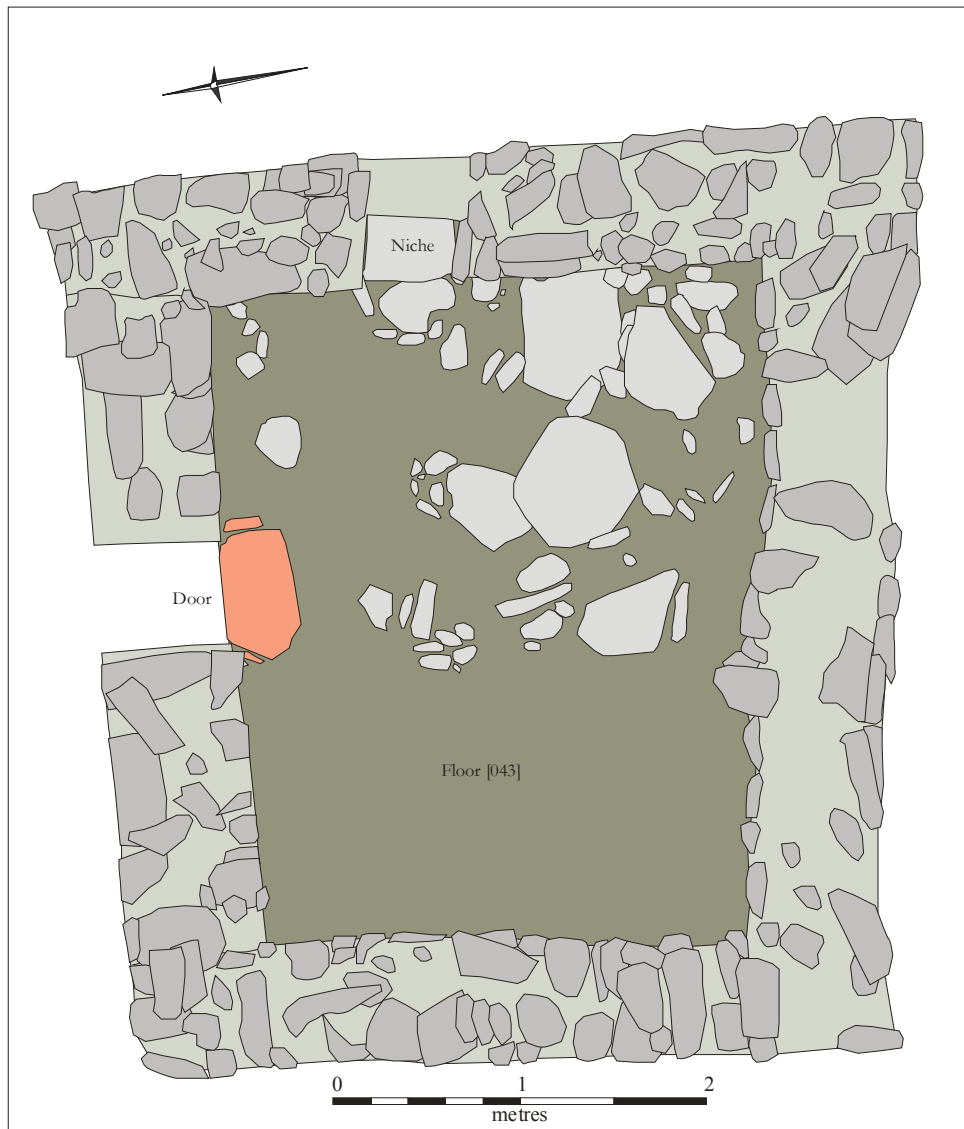
Figure 14: Southern room of Structure 1

This part of the building consisted on a single ‘room’ and was slightly trapezoidal in shape, measuring 2.60m-2.90m N/S and 3.4m E/W internally. A door, 0.70m wide, lay along the N side while a niche or cupboard lay within the E wall, this measuring 0.50m by 0.40m. There is the possibility a second, now blocked, niche existing in the opposite W wall. The walls [002] were mainly constructed in epidiorite rubble and stood up to a height of 1.30m (although this was as little as 0.46m high on the NE) and up to in 0.80m in width. Little bonding material was in evidence in the walls although patches of lime mortar were seen adhering to the face of the niche, which might indicate secondary work or repair.

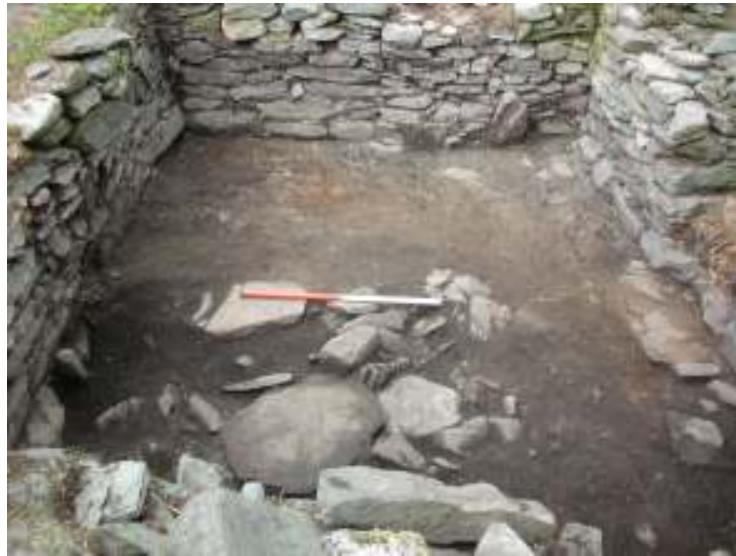
Structure 1 with threshold at right of picture

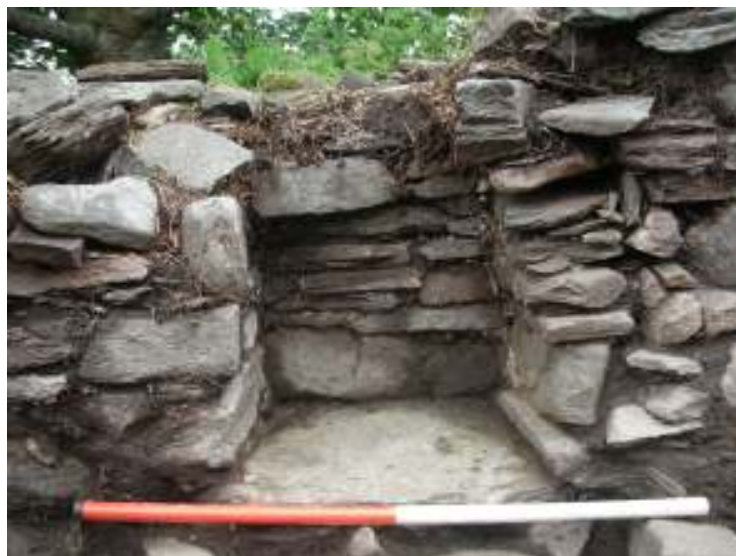
Structure 1 Niche with traces of mortar on inner face

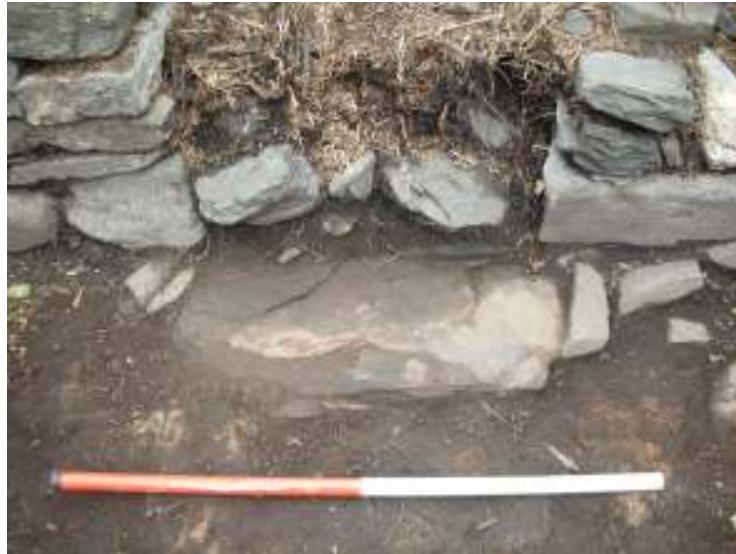
Threshold stone and possible early hearth

This lowest deposit reached was a mixture of midden material and large stones [046], the latter perhaps laid as a rough make up prior to construction of Structure 1. This was sealed by a relatively even deposit of mixed silt clay and redeposited burnt peat ash [043], likely a floor accumulation. A threshold stone marked the entrance into the building and this displayed distinct signs of burning as did the floor deposits lying immediately to the S, although there was no apparent trace of any such burning on the entrance walls. It is possible that what became the threshold stone was originally a central hearth within an open building, this later divided by the later addition of cross walls which also appear to abut rather than tie into the walls at the E and W.

The threshold stone and its associated floor and were sealed by a trampled midden deposit [032] that appeared to be concentrated around the doorway. This deposit contained numerous animal bones along with a few iron objects and green glazed pottery dating to 15th/16th century. This in turn was sealed by a very humic deposit that may represent another midden/surface [021] deposit, again most of the recovered artefacts were situated around the entranceway. Contemporary with this surface was a deposit of charcoal and burnt peat [031] that indicates a fire/hearth position on the W side of the room. No formal floors are seen thereafter and it may be this building may have no longer been directly occupied, with a build up of a series of trampled rubble and humic accumulations [022]/[023] and [006]-[009] that possibly suggest animal penning? These are then sealed by an extensive accumulation of wall collapse [001].

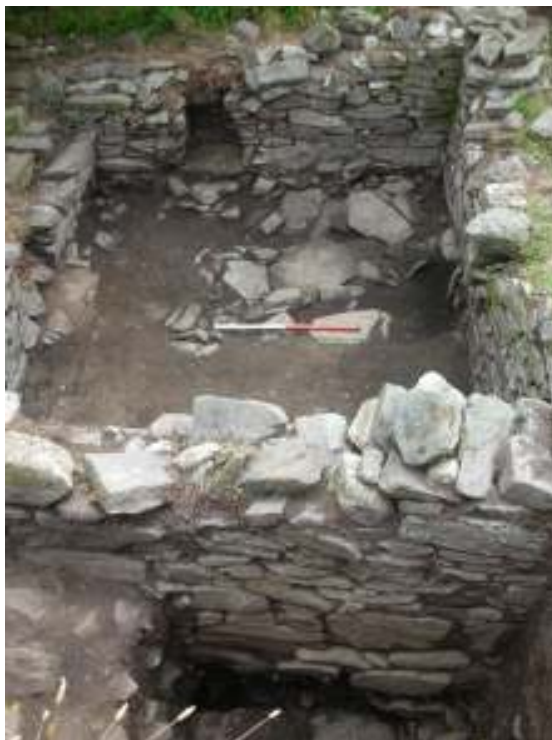
Structure 1 from W

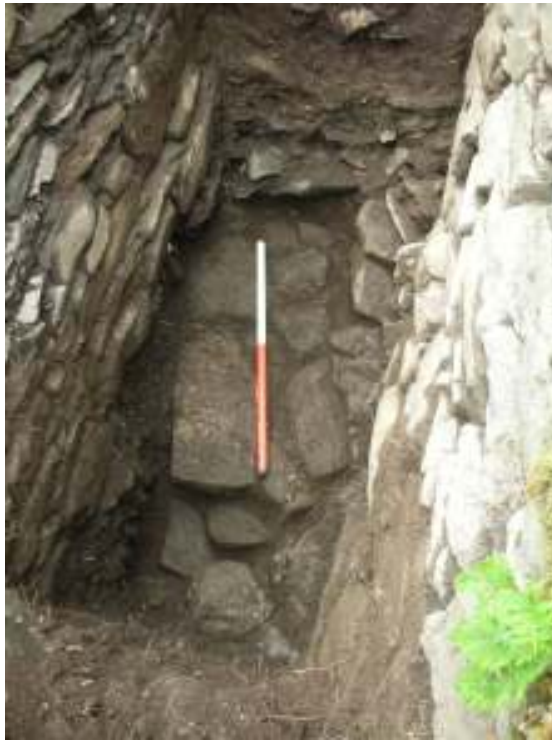
Early wall alignment [067]

The earliest feature uncovered was what would appear to be the remains of the original line of the dun wall [067], although the limited nature of the trench on this side of Structure 1 makes it difficult to be sure. This wall roughly aligns with the inner face of the wall seen to the S, described by the RCHAMS as a 'sudden intake' (RCHAMS 1988) and it may be that this actually represents the earliest wall of the dun albeit modified at later periods. This early stretch of wall was sealed by a very dark organic midden dump [042], containing bone, shell and pot, the latter dating to the 13th century. This deposit likely corresponds to similar deposit [046] encountered within Structure 1. Above this midden dump were two mixed deposits [044] and [048] that may be related to the construction of both Structure 1 and the inner face of the upper enclosure wall [041]. The footings of both these structures were at the same level and suggested they were constructed around the same time, whereas the original dun wall was rebuilt and 'widened' to incorporate Structure 1. The upper extent of deposit [044] recorded as [033] shows that it had been trampled, while [044] itself and contained some midden material. This was sealed by a deep deposit of very humic blocky material indicative of a dried peat accumulation [029]. Given that this deposit also sloped down to the N from the SW external corner of Structure 1 it is likely this was a peat store at the rear of the building. The peat deposit is in turn sealed by collapsed rubble [028], this either deriving from the enclosure wall or Structure 1.

[067] Wall. Alignment of original dun wall? Unexcavated

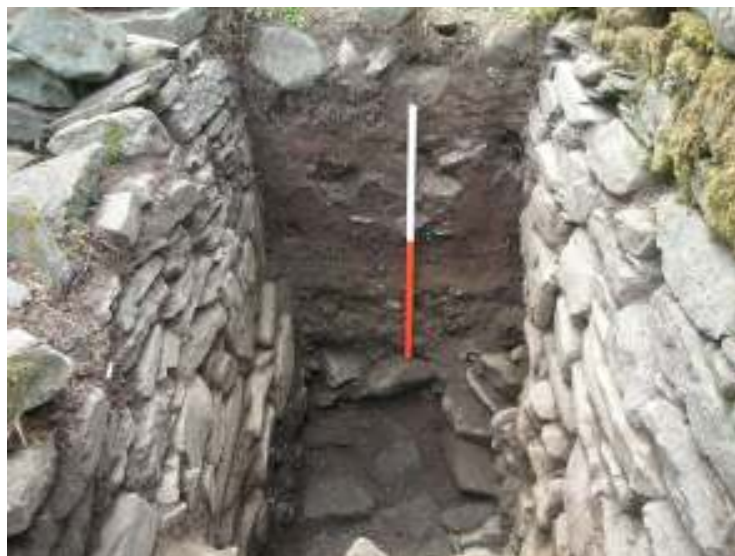
N facing section of deposits between Structure 1 and enclosure wall

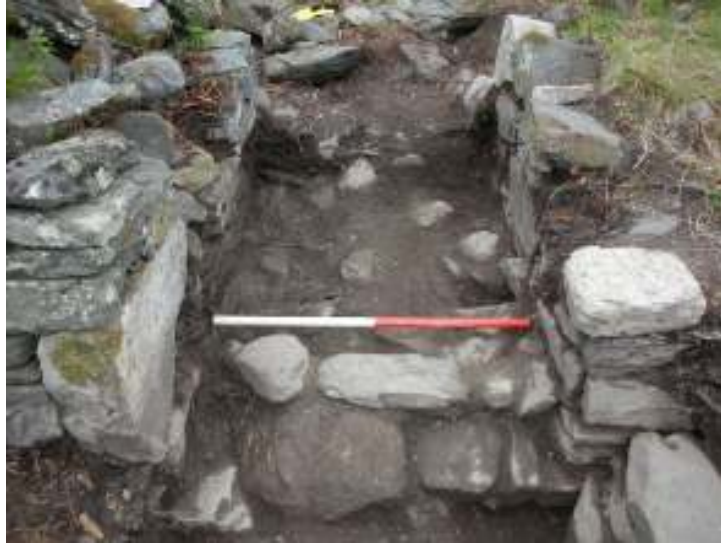
Upper enclosure entrance looking N

Given the amount of rubble present within the entrance and hornwork the trench was more limited in size than originally planned. Rubble however was removed from within the entrance passage and from over the NE wall of the 'hornwork' [062] and over the putative garderobe chute [063]. Removal of rubble [047] within the entrance revealed this was 1.03m wide and 1.70m long with passage walls standing at 1.0m high at the W and 0.80m on the E. Between the passage walls there is what appeared to be a revetted surface of flattish stone slabs and clay [060].

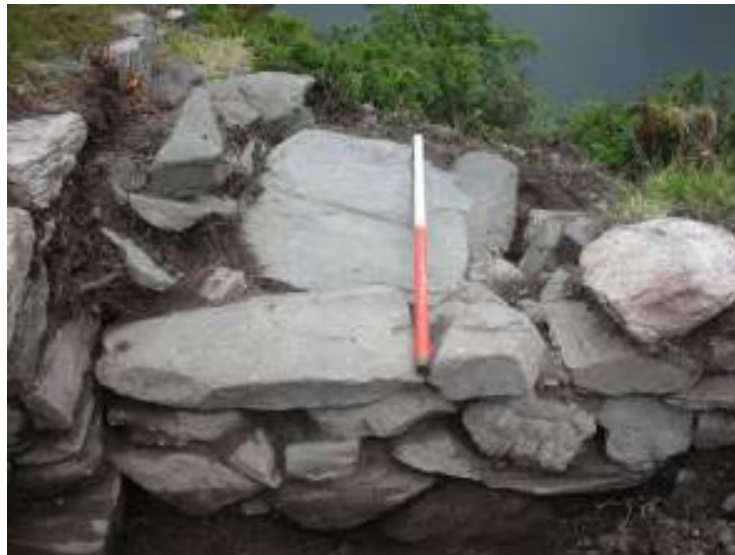
NE end of hornwork wall with reused threshold stone

This lay over what may be the line of the original enclosure wall. Removal of rubble [045] from the S of the entrance revealed the inner face of the hornwork which abutted the enclosure wall [065].

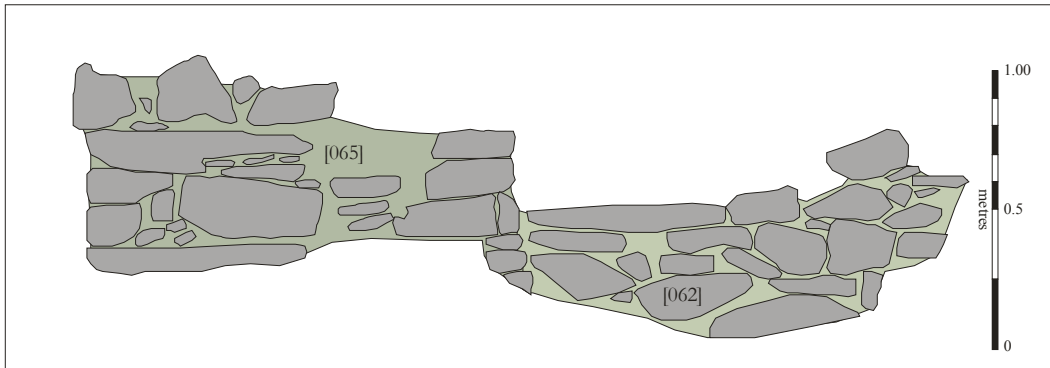
Figure 18: W facing section of upper enclosure entrance and hornwork

Rubble was also removed from over two projecting ‘chute’ stones. These appear to have been inserted by cutting through the original hornwork wall and as yet their function remains unclear, but the suggestion that they are a drain or wardrobe chute appears attractive. Any gap or channel above these stones may then have been blocked by the later reestablishment of the ‘hornwork’ wall, this utilising a threshold stone in its build. Both the rubble within the entranceway and that to the S contained animal bone, shell and pot, suggesting the dumping of midden material within this part of the site.

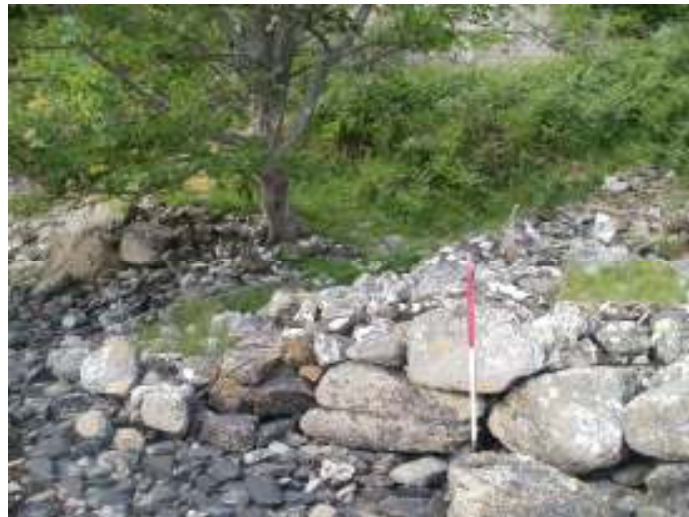
Naust from NE

A naust is positioned immediately below the steep near-vertical eastern rock face of the Dun promontory on the foreshore of Linne Mhuirich. This is roughly rectangular in shape running eastwards from the base of the cliff to below the low-water-mark in the sheltered loch. The feature is delimited by a rubble mound on its northern side faced with a large boulder wall at its eastern terminal [072]. This area consists of a contained mound of rubble, probably originally constructed with a levelled top to create a 'hard' surface. Internally the naust has a length of c.4.80m and a c.3.70m width. At its southern side the basal remains of a roughly built wall run from the upper foreshore area to a double-kerbed terminal below the low water mark. This feature would originally have provided a degree of shelter for the naust and would also have marked its seaward entrance. The rear of the naust is marked by the basal remains of a low cross wall. A small hollowed out area survives behind this against the cliff face and might possibly have been used for storage originally. Further level areas are visible topographically around this area and may have served a similar function.

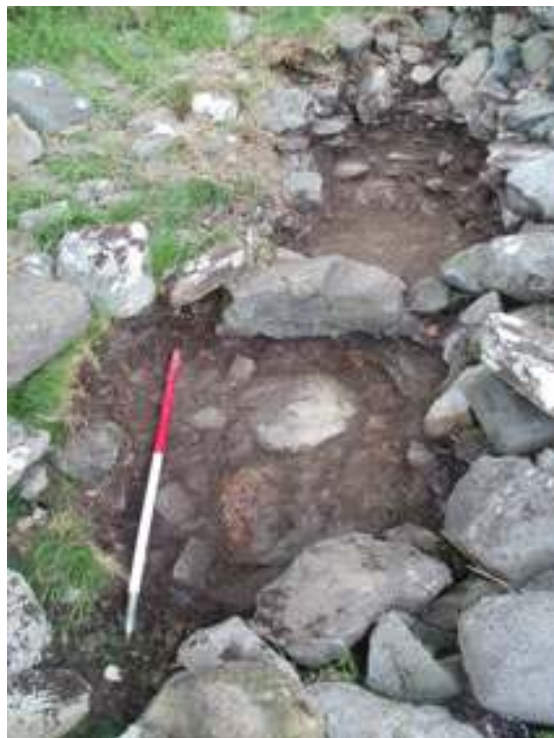
Naust paving [070]

The excavations and survey at this feature have confirmed that it would have functioned as a naust. Unfortunately no dating evidence was recovered but it was likely constructed during the medieval period to facilitate a medium sized wooden vessel that would have been used by the Dun occupants. Its direct landscape association with the settlement site above and the associated works along the

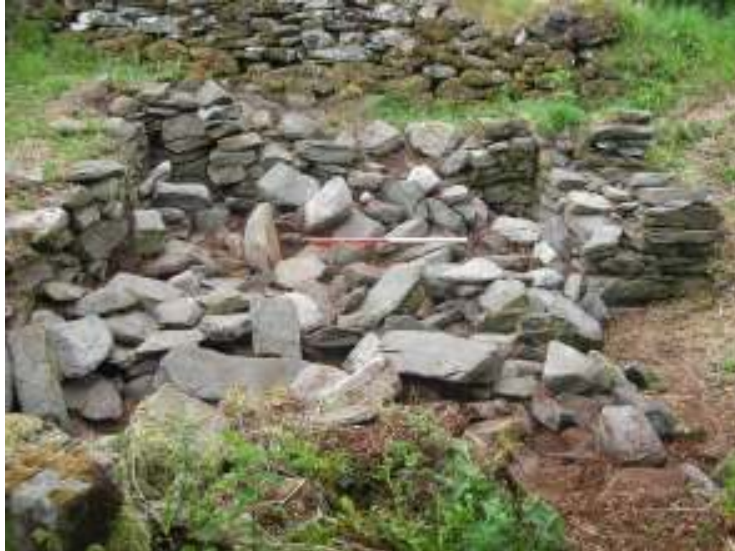
[001] Layer. Upper rubble collapse within Structure 1, consists of medium to large epidiorite blocks within a dark brown humic silt; some fragments of mortar were also in the collapse.

Rubble [001]

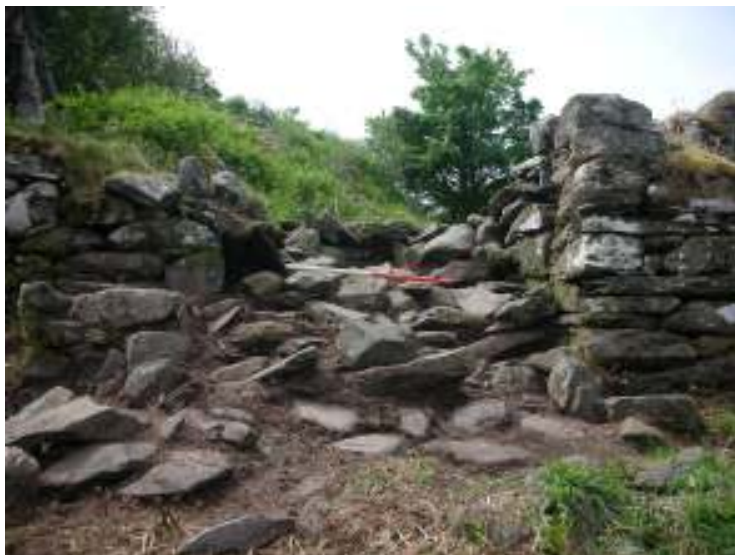
[003] Layer. Rubble collapsed within entrance of lower enclosure. Mainly epidiorite and quartz blocks, collapsed or pushed into entranceway. There is some indication of attempts at rough coursing across upper rubble. Between the collapsed material was a dark grey brown clayey silt with bone and shell fragments.

Rubble [003] in lower enclosure entrance

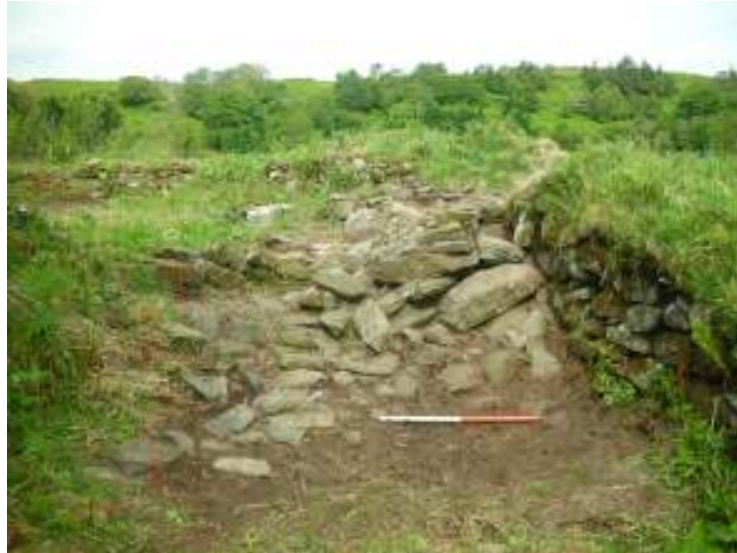
[004] Layer. Rubble collapse E of entrance pier and later wall. Consists of large to medium epidiorite blocks (maximum 0.83m x 0.50m x 0.20m). The upper blocks have voids between, suggesting sudden collapse. The lower blocks sit within a dark brown humic matrix with bone, shell and occasional iron object.

Rubble collapse [004]

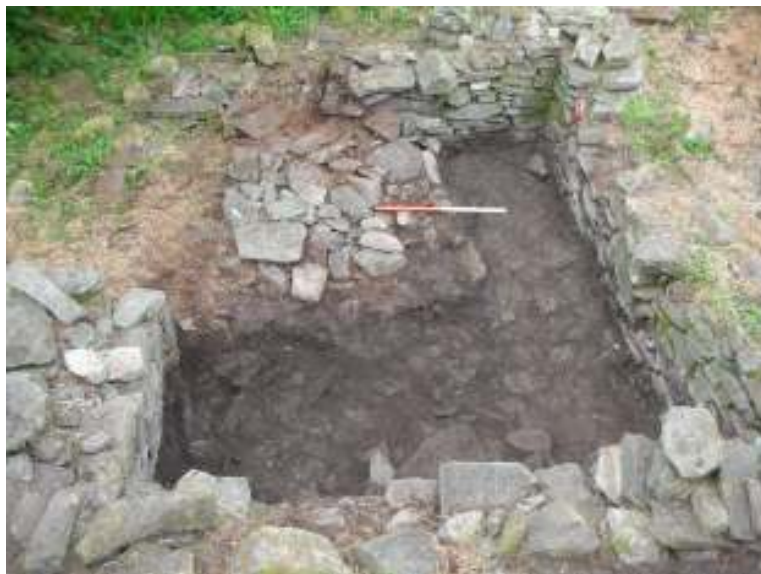
[007] Layer. Lower stone collapse or spread, possibly a rough floor.

[008] Layer. Lower stone collapse or spread, possibly a rough floor.

Possible surface [006]-[009]

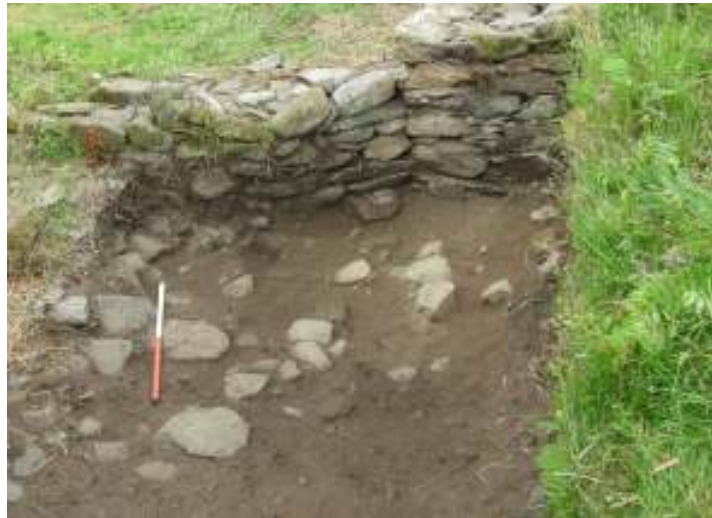
[013] Layer. Mid brown silty clay, includes occasional fragments of lime mortar, bone, charcoal and shell.

Surface [013]

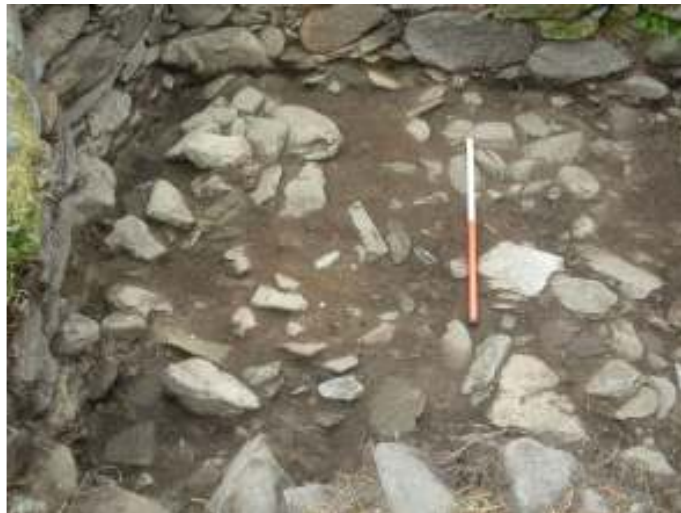
[015] Layer. Mid brown silty loam with patches of fire reddened material (peat ash), includes moderate charcoal and occasional bone.

Surface [015] and area of burning

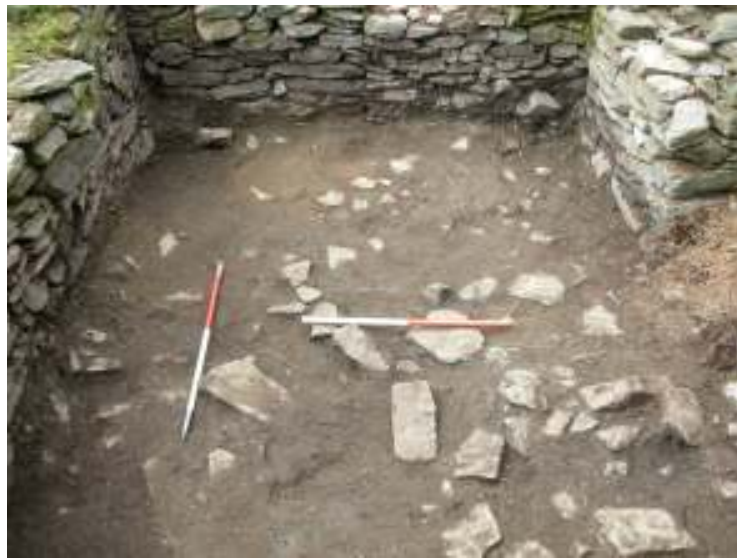
[021] Layer. Grey brown silty humic clay, with moderate bone and occasional glass and iron object.

Surface [021]

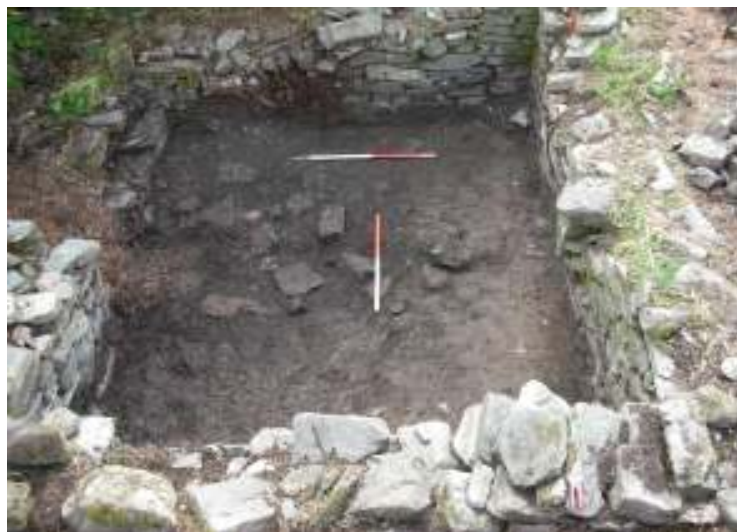
[022] Layer. Stone collapse or rough flooring.

Possible surface [022]/[023]

[023] Layer. Stones lying flat, possible a rough floor surface.

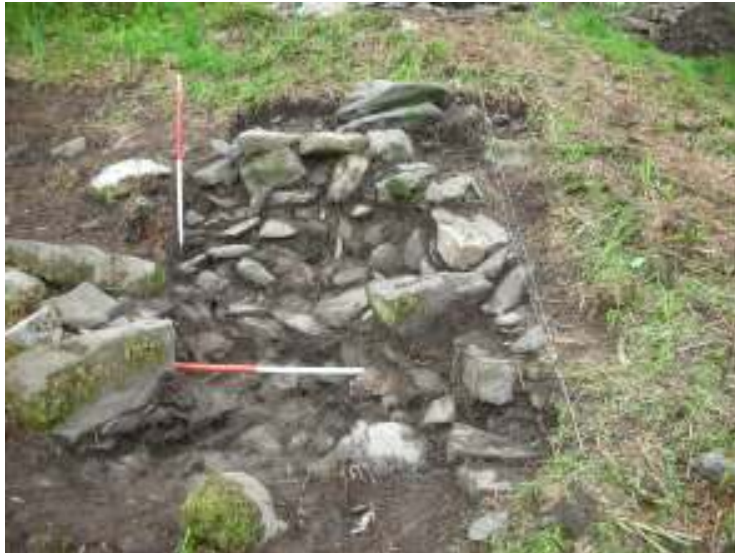
[024] Layer. Stone collapse within a dark grey brown clay matrix with occasional schist fragments and mollusc shell.

Rubble [024] over S wall of Structure 1

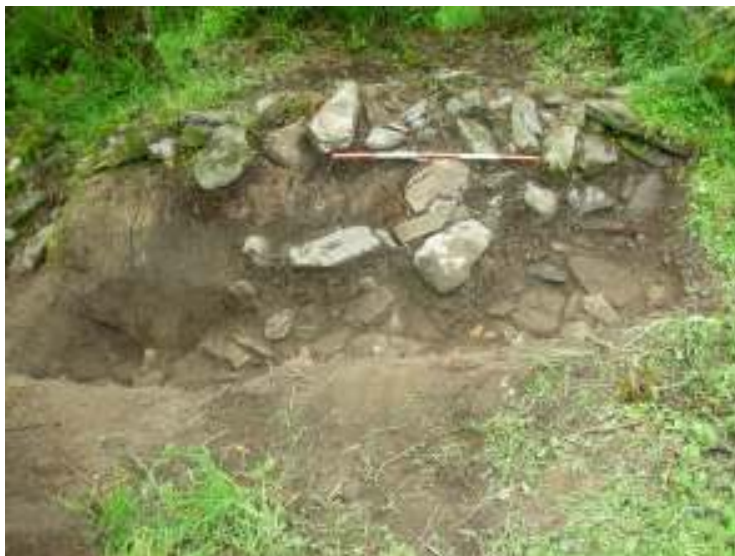
[025] Wall. Badly disturbed collapsed wall remnants at NE of possible building. Highest part stands up to three courses high of coarsely laid rubble (0.30m high) up to 0.45-0.50m wide (largest block 0.70m x 0.27m x 0.12m).

N wall of Structure 4 [025] over limestone outcrop with rubble [027] to N

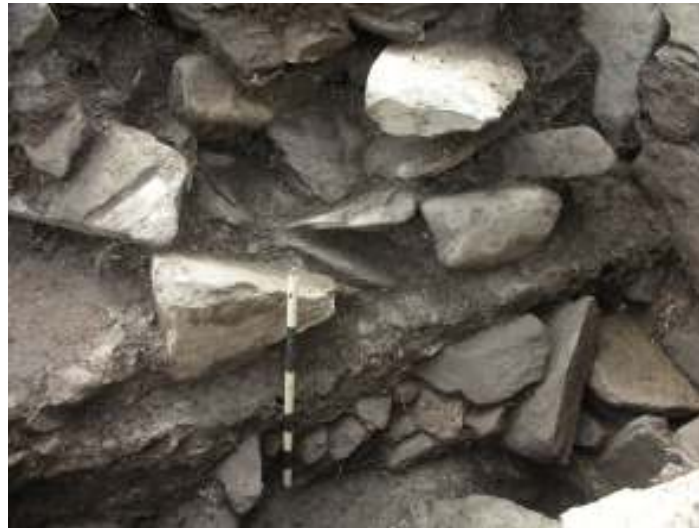
[034] Layer. Loose greyish brown silt mixed with frequent crushed angular schist slabs and occasional charcoal.

W facing section through [034] over [035] in Structure 3

[035] Layer. Uneven layer of angular stones.

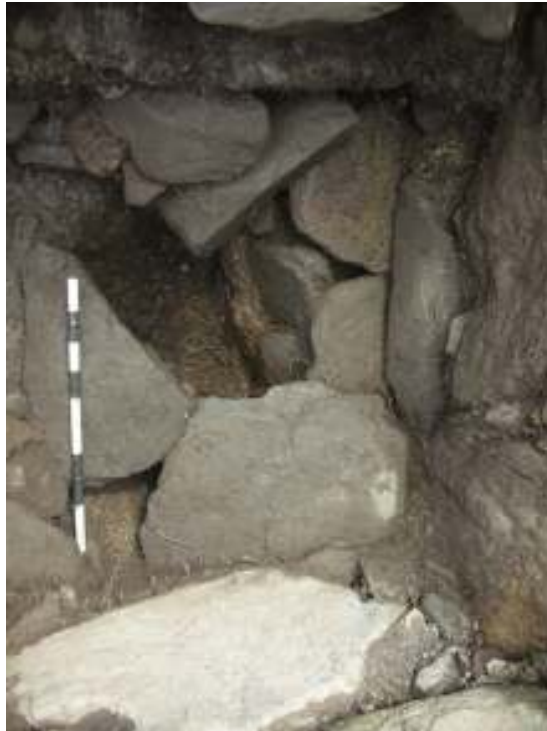
[036] Post Hole Cut. Sub rectangular cut measuring 0.60m by 0.30m and 0.30m deep with near vertical sides and concave base.

Post hole [036] Structure 3

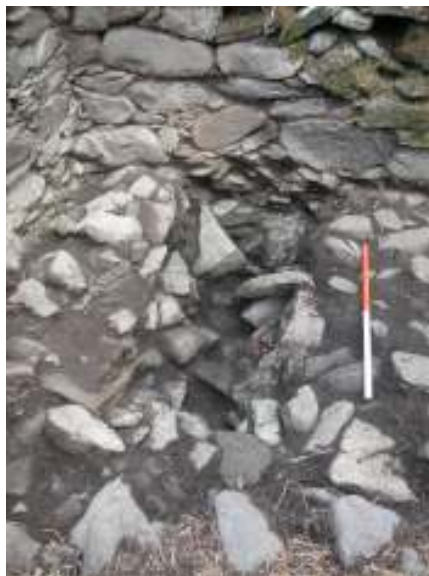
[037] Layer. Dark grey humic silt, includes frequent small schist fragments and occasional medium stone blocks, frequent charcoal fragments and occasional bone, dumped in amongst/over larger blocks which were left in situ.

Sondage through [037] in Trench 3

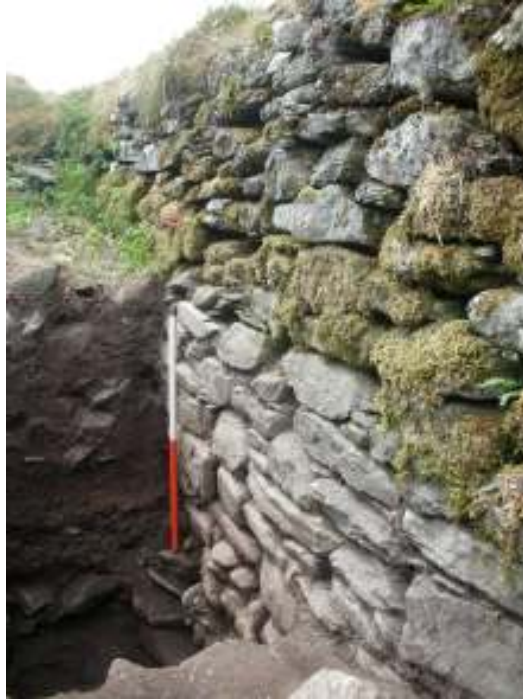
[041] Wall. Inner face of upper enclosure seen in Trench 5 it stands 2.10m high in up to 17 courses .

Inner face of upper enclosure [041]

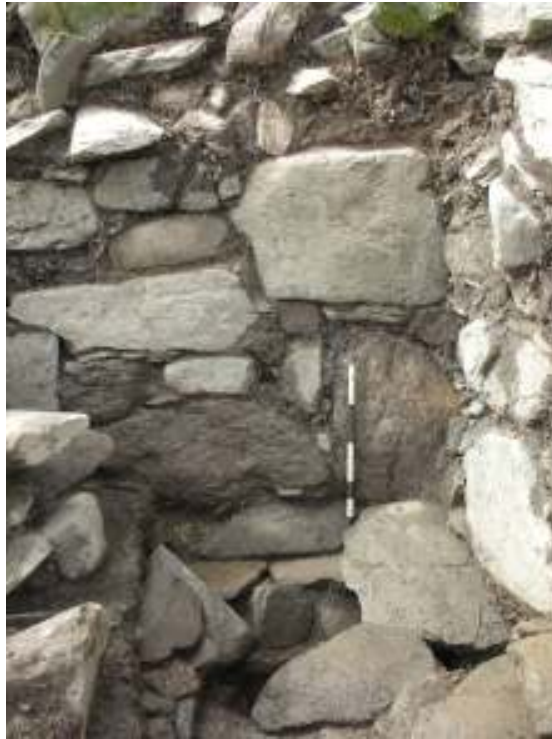
[049] Scarcement. Level stone ledge between 0.15-0.17m wide and standing 0.18m high.

Scarcement [049] at foot of wall [051] of Structure 3

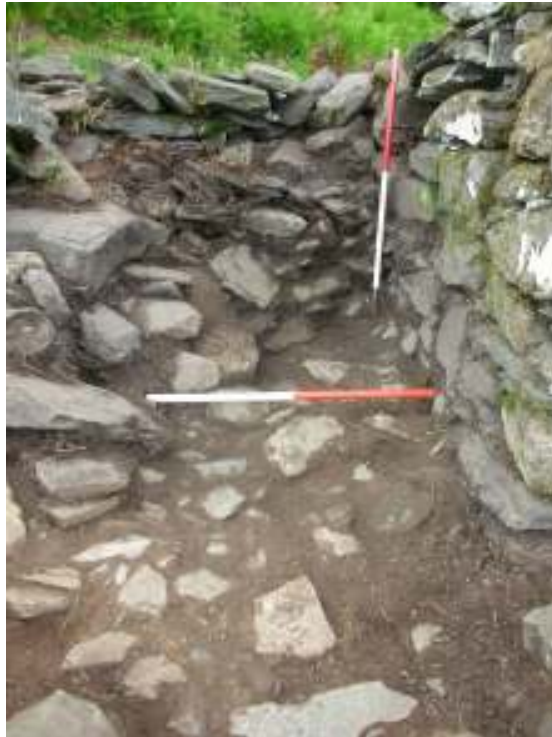
[052] Surface. What may have been the latest surface within the entrance consisted of flattish stones within a mid brown clay matrix with some fragments of light brown mortar. Not excavated.

Possible surface [052] in lower entrance

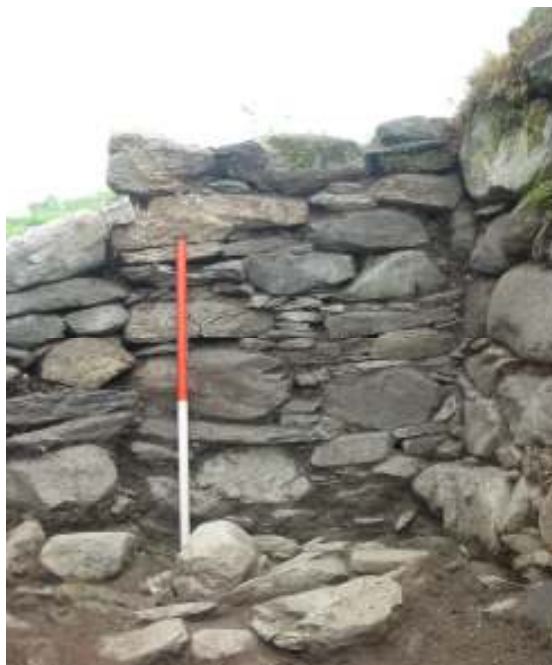
Pier [053]

[053] Pier SE. Rectangular stone abutment measuring 1.10m by 0.60m and standing 1.20m high in seven rough courses (largest stone 0.63m x 0.30m x 0.18m).

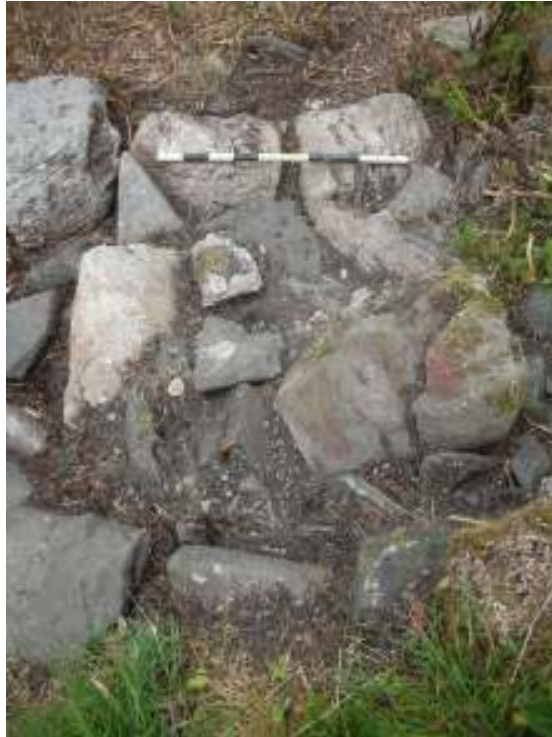
[054] Pier SW. Not fully revealed but the top of this rectangular stone built feature measured 0.84m long and 0.70m wide.

Pier [054]

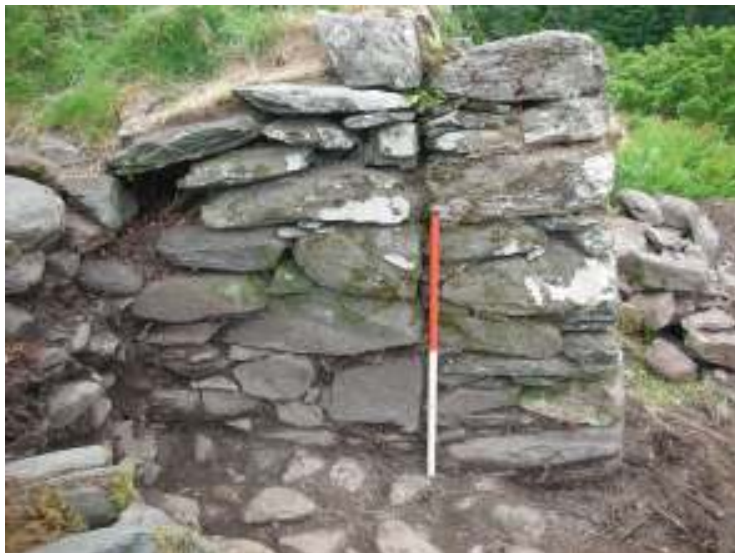
Pier [055] to the N of the original entrance wall

[055] Pier NW. Rectangular stone abutment measuring 0.80m-0.82m by 0.90m and standing 1.67m high in nine rough courses (largest stone 0.66m x 0.32m x 0.22m)

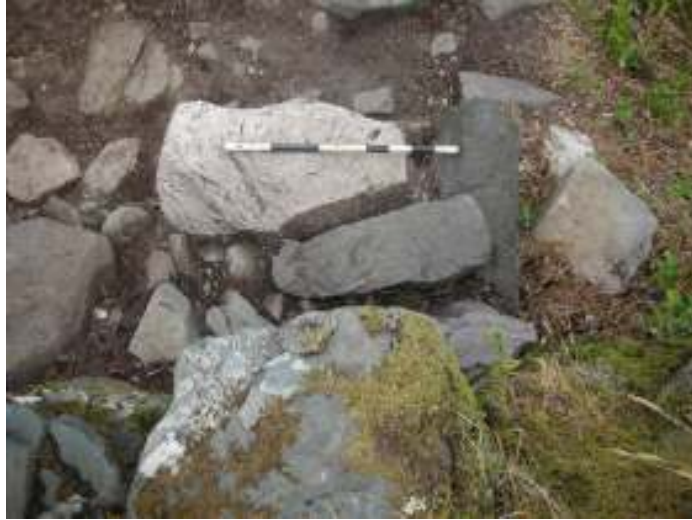
Pier [056]

[056] Pier NE. Rectangular stone abutment measuring 0.80m by 0.83m and standing 0.46m high in two rough courses.

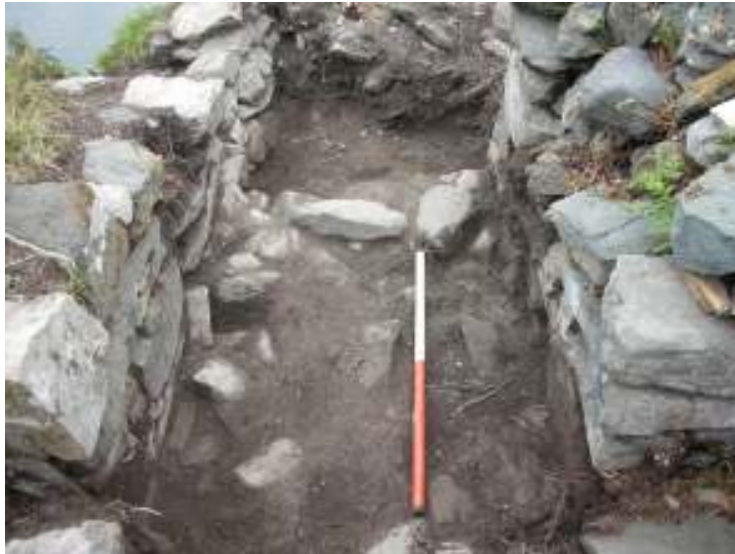
[060] Surface. Surface in upper enclosure entranceway lying below walling collapse. Possibly revetted by a line of stones on its S side, this possible surface consists of flat stone slabs in a compact blue grey brown clay silt matrix. Not excavated.

Surface [060] in upper enclosure entrance

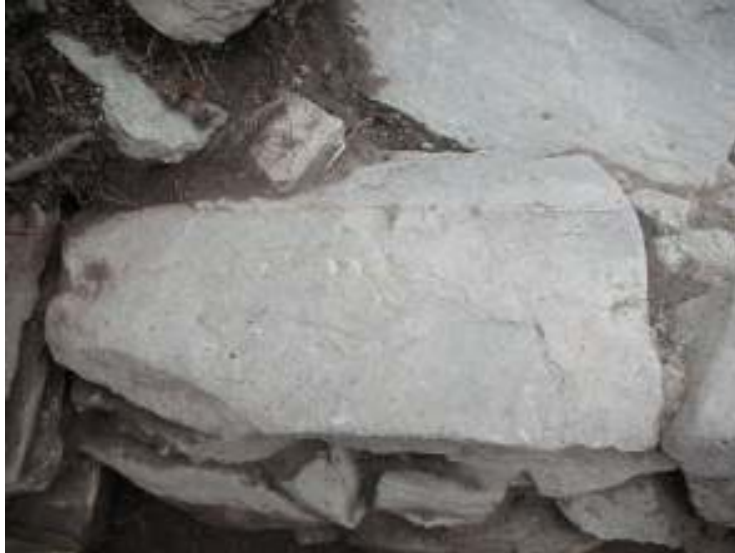
[062] Wall. The northern end of the hornwork wall that springs from the SE side of the upper enclosure entranceway. This may be re-blocking of a drainage chute, the wall as revealed standing 0.73m high and 1.16m wide. A reused threshold stone was included in the build.

Wall [062] reused threshold stone

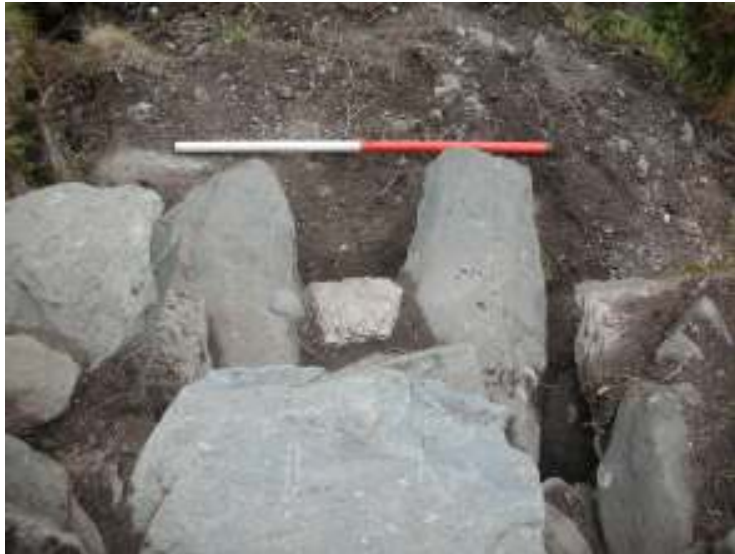
[063] Chute. Possible chute inserted into/above original hornwork wall and later blocked? by [062]. The chute consists of two large projecting parallel schist blocks extending 0.40m E beyond the original wall line.

Possible garderobe chute [063]

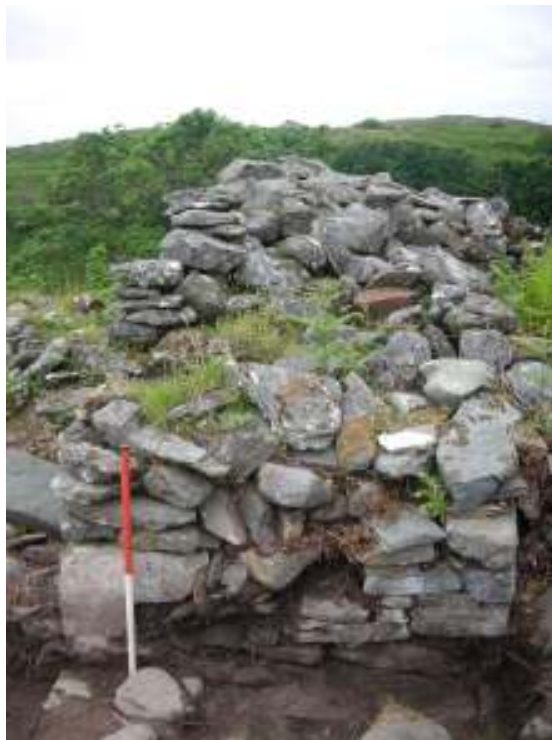
[064] Wall. Forming W side of entranceway is 1.00m high and 1.70m wide.

W side of upper enclosure entrance

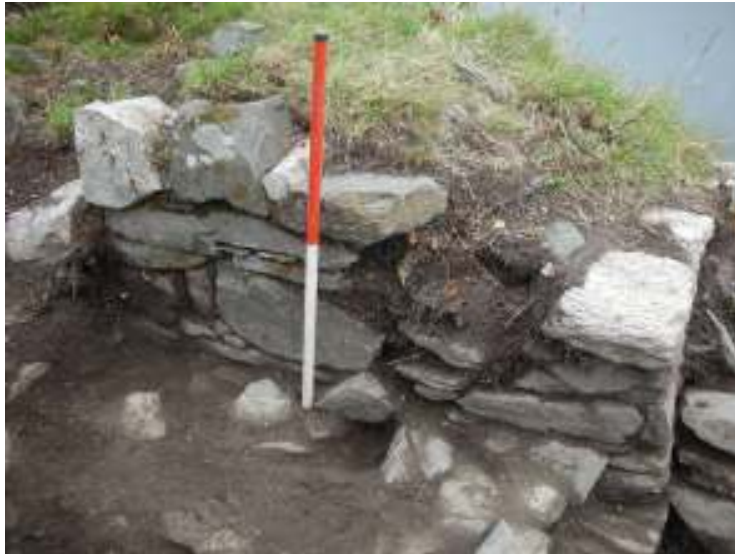
[065] Wall. Forming E side of entranceway is 8.86m high and 1.70m wide.

E side of upper enclosure entrance

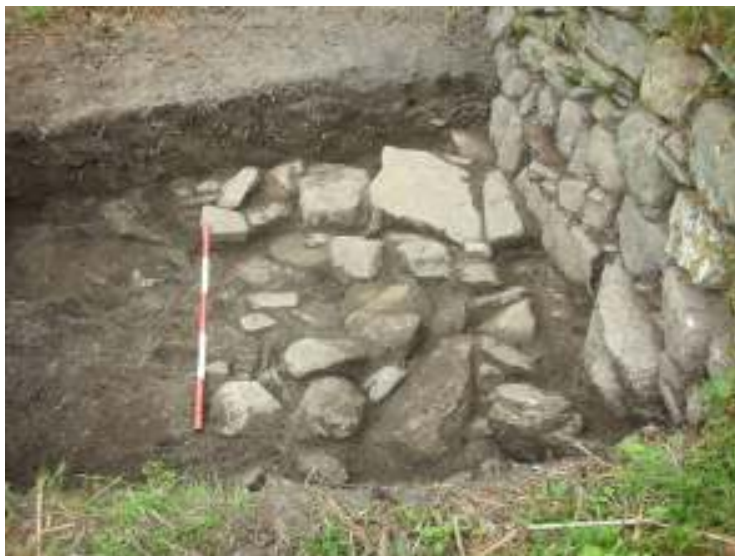
[066] Surface. Rough cobbled/slab surface running along E face of lower enclosure wall, consists of angular and water rounded stones (maximum size 0.65m x 0.32m x 0.10m)

Surface [066]

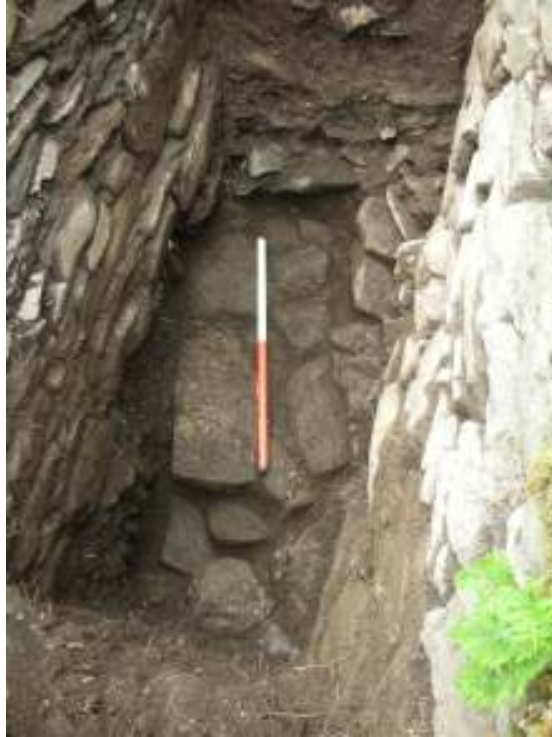
Wall [067] lying below all of Structure 1

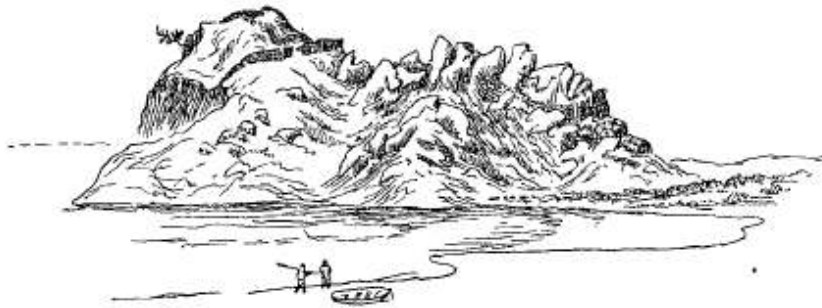
Fig. 33. Dun Mhuirich, Loch Sween, from the north.

Dun Mhuirich, Loch Sween.—On the Linne Mhuirich, a narrow inlet 2½ miles long which runs parallel with Loch Sween on its west side. The fort is on a bay on the west side of and about half-way along the Linne, and is 2 miles S.S.W. of Tayvallich Church. By some mistake Miss Maclagan calls it Dun Tayvaellach, confounding it with Dun a' Bheallich, close to the church (op. cit., pp. 43, 44). The fort stands on an isolated rocky ridge rising abruptly from the flat and marshy strip of plain that runs along the coast at the foot of Dun Mor (367), half a mile to the east. Retired and deserted as the neighbourhood now is, yet it seems to have been well peopled formerly, as on the slopes of Dun Mor, or near them, six hamlets or farms, Barr Breac, Barr Beith, Druim-nan-gall, North Ard Beg, Barr Thormaid, and Kilmory, are marked on the O.M., all within half a mile of the fort. As approached from the north, the fort on its rocky site comes suddenly into view at a turn of the road, presenting the remarkable aspect seen in fig. 33. The ascent is easy enough from the bay by the hollow shown in the sketch. But the east side rises sheer from the sea, and the west side and south end are so precipitous as to be practically inaccessible.

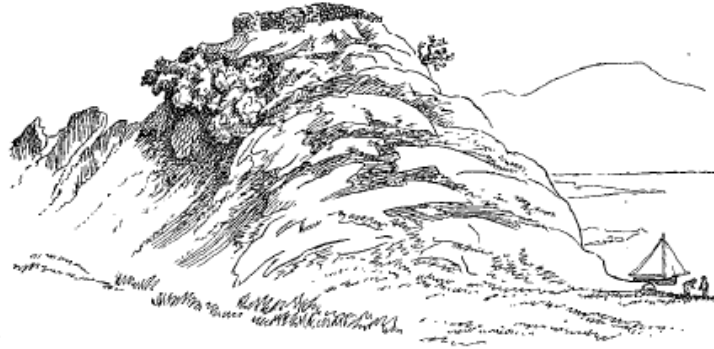
Fig. 34. Dun Mhuirich, from the south.

Not less remarkable in appearance than the north end is the south end, which seems bound together by bands of rock, smoothed and polished by glacial action (fig. 34). Seen from the ridge of confused disrupted rocks to the north (fig. 35), a curved outer avail, well built and 4 to 5 feet high in places, running down to the sea cliff on the east, enclosing a terrace on the west, and having an entrance in the middle of its north face (sketch plan, fig. 36), with steps leading up to it, is a prominent object. It is 9 feet thick at the entrance, narrows to 6 feet at the west side, and is a mere supplement to the natural defence of rock at the south end, where it runs out at the sea cliff; Towering above, and approached by climbing up a rocky spur, is the inner wall, more ruinous and without any visible entrance. This wall completely encloses the interior, and is 7 feet thick at the curved ends, but only 3 at the nearly straight sides. At the ends it is 5 feet high in places on the inside, and on the west side it is a foot higher. It is very well built of dry masonry. Miss Maclagan speaks of a third wall, but I could see no sign of it. Neither is there any place where another wall could easily be placed. I found the level interior, measured by tape, to be 54 by 38 feet, although Miss Maclagan, in pursuit of her circular theory, calls it 60 feet in diameter.
